Observation Survey of Keward Brook, St Andrew's Stream and St. Thomas's Stream, located in Wells Somerset

– Conducted by Teleost Consulting on behalf of Wells Civic Society

09/05/2016

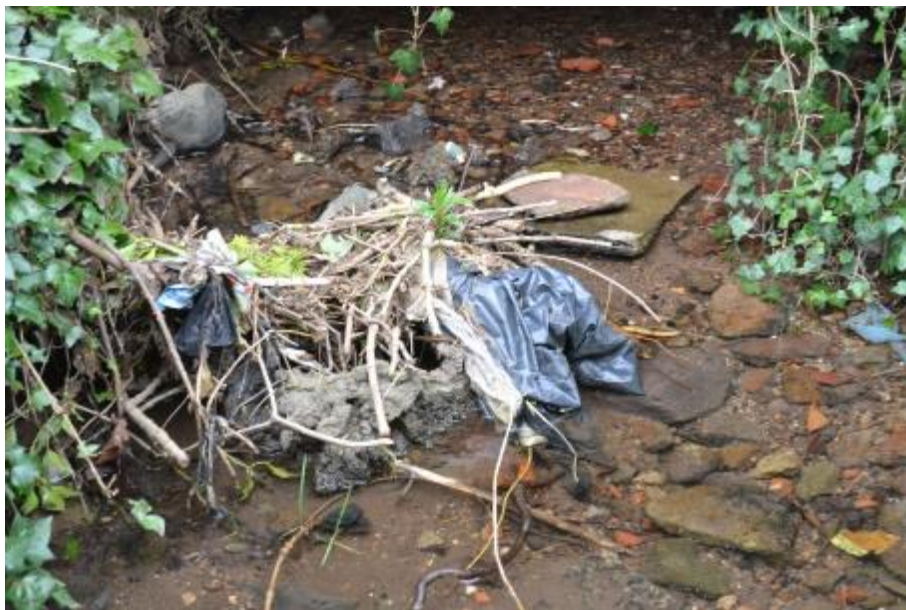
The Brook begins close to Wells Moat where it appears from the tunnel displayed in Figure 5. The brook passes through a gully that is vegetated by a simple vegetation structure (Figure 6). The substrate was found to consist predominantly of cobble (Figure 7). Notable amounts of litter were present at, and downstream of, this survey point (Figure 7).

Figure 7: Litter in Keward Brook stream channel at survey point KB1.

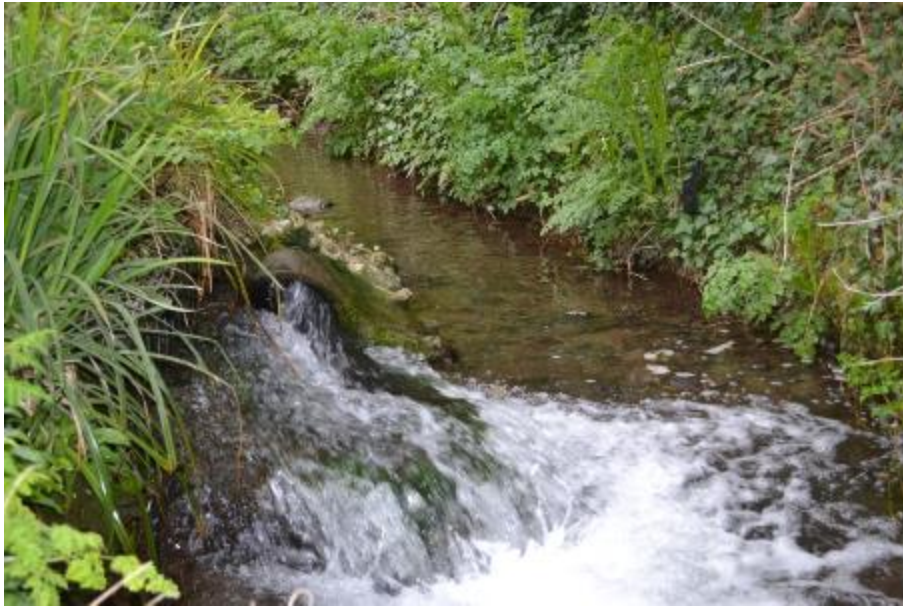
The surrounding land use is classed as sub-urban/urban (asphalt footpath) to the right bank and unimproved grassland to the left bank. Additional water enters the brook directly from the moat via the pipe displayed in Figure 8. Downstream of this pipe, modifications (stone bank reinforcement) are visible on the right bank (Figure 9). Downstream of this pipe the bankside vegetation becomes overgrown with the stream barely visible (Figure 10).

Figure 8: Upstream view of secondary outflow from moat approximately 50m downstream of survey point KB1. Pipe diameter = 30cm.

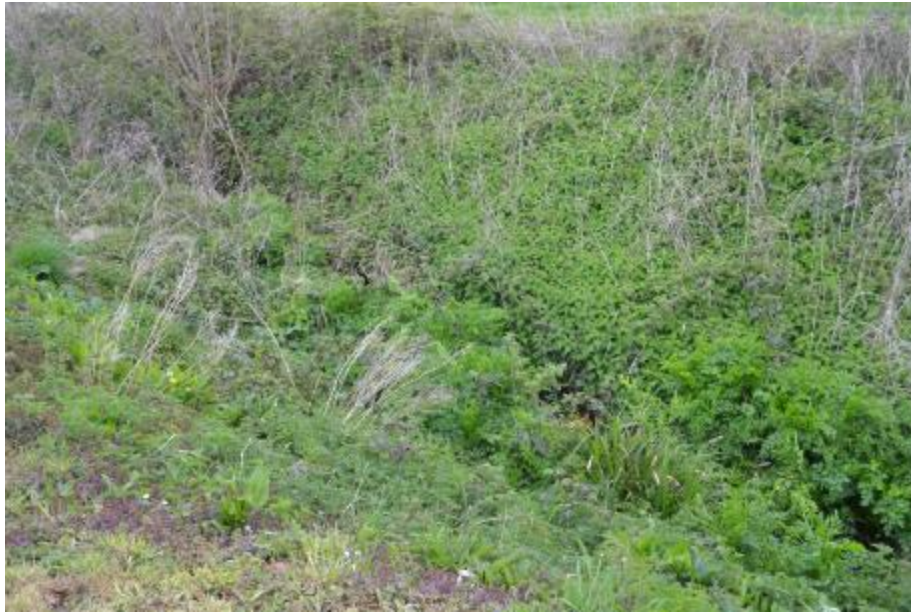
Figure 10: View of Keward Brook from the right bank approximately 80m downstream of survey point KB1. Steam is barely visible due to overgrown vegetation.

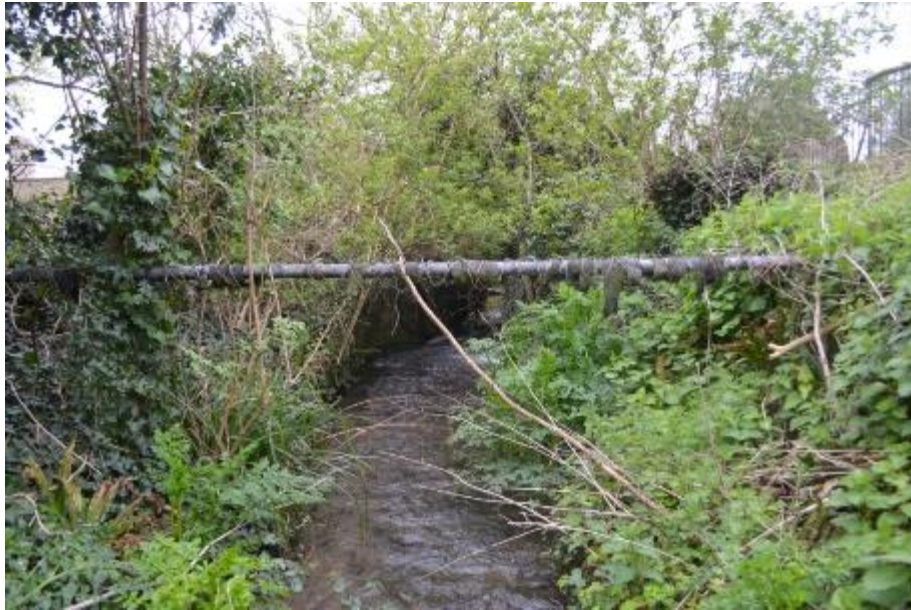
A metal bar wrapped in barbed wire bridges over the stream approximately 20m downstream of survey point KB2. The reason for this existence of this bar, that is visible for the public footpath, is not known.

Figure 13: Downstream view of Keward Brook approximately 20m downstream of survey point KB2. Note the metal bar wrapped in barbed wire bridging over the stream.

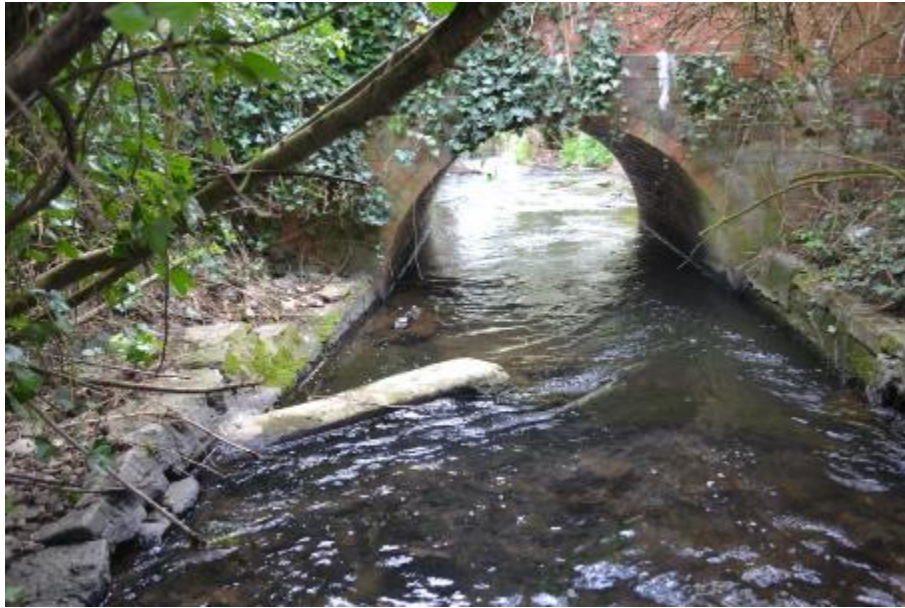
A downstream facing concrete groyne is located on the left bank in between the second and third bridges found along this section of brook (Figure 26). The deflector concentrates the current whilst pushing it towards the right bank. The result of this is a small pool where the substrate has been scoured by the increased flow.

Figure 26: Downstream view of the third bridge located downstream of survey point KB5. Note the downstream facing concrete groyne on the left bank.

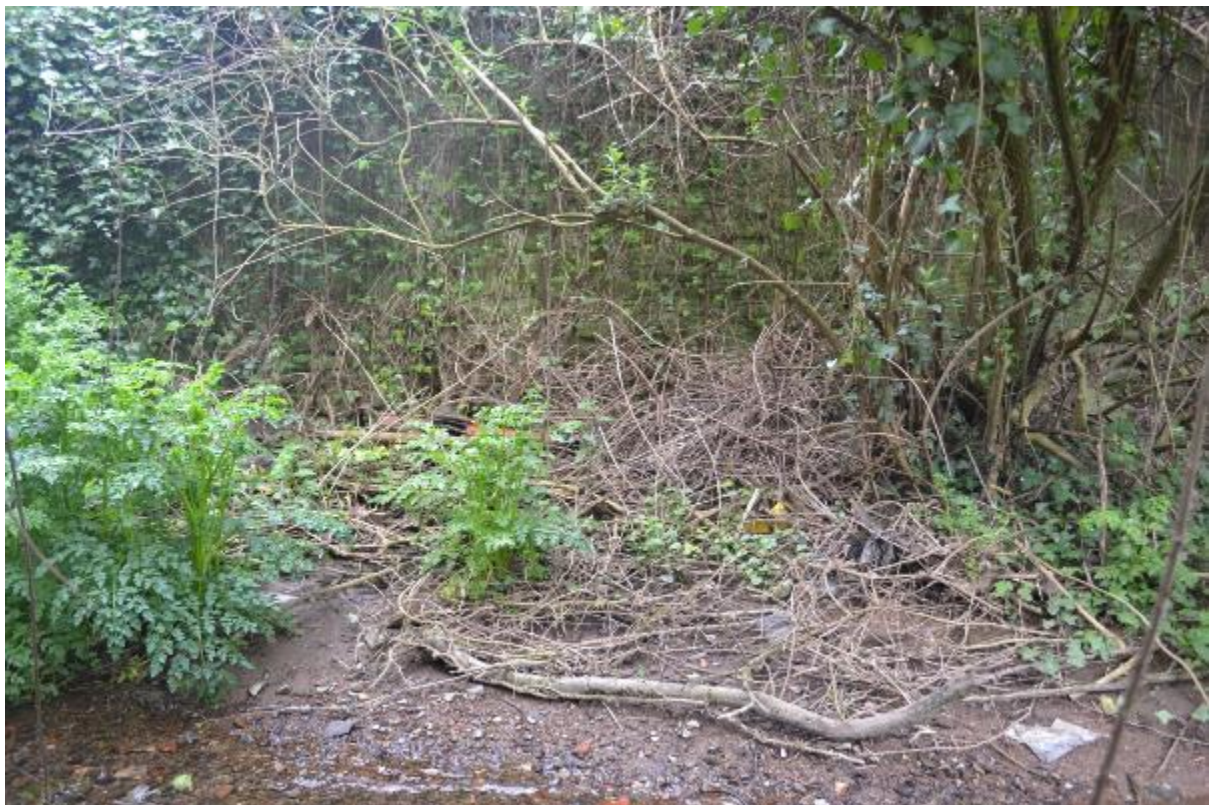
Figure 31: Litter along the right bank of Keward Brook, approximately 30m downstream of survey point KB6.

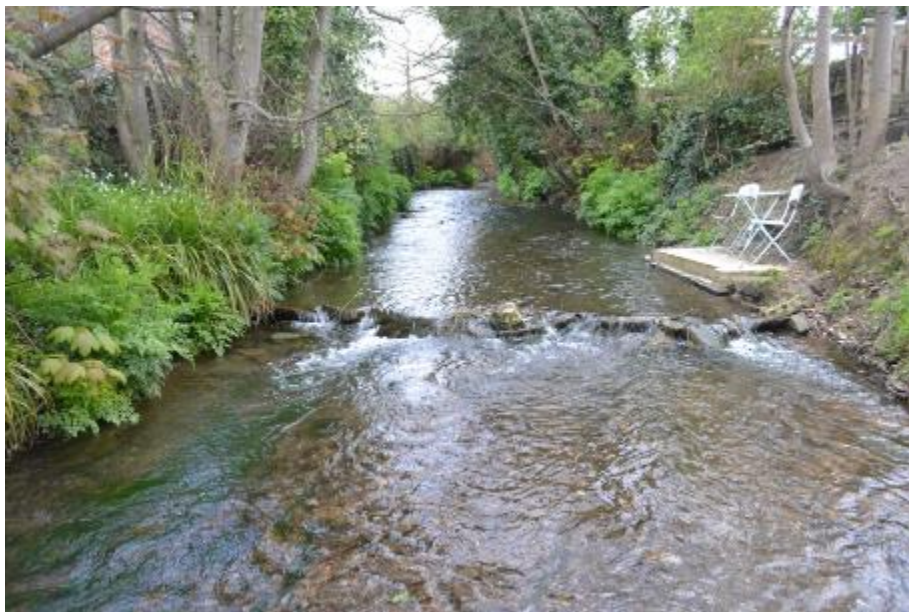
Figure 33: Upstream view of Keward Brook approximately 70m downstream from survey point KB6. Stones have been place across the channel that will, in time, cause a pool to be created.

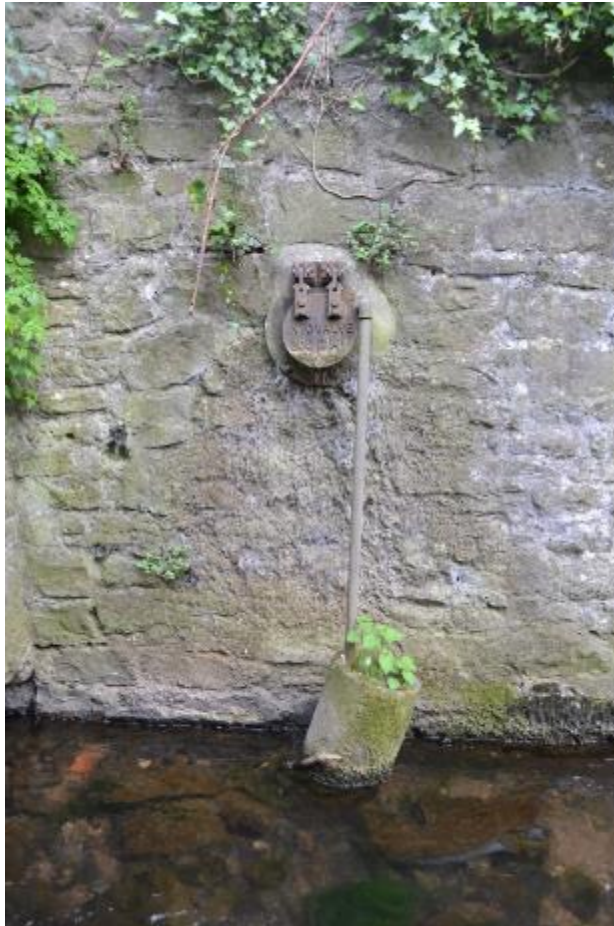
Figure 35: A 22cm diameter discharge pipe on the left bank at survey point KB7. No odour was present and no effluent was being discharged. Minimum staining is visible on the wall beneath the pipe.

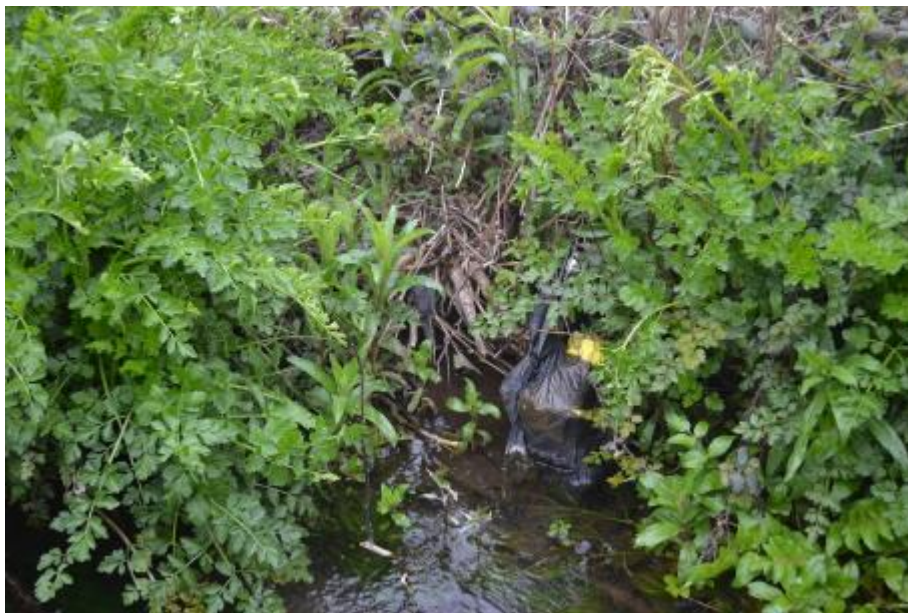
Figure 55: Litter present along the left bank margin of Keward Brook, approximately 25m downstream of survey point KB11.

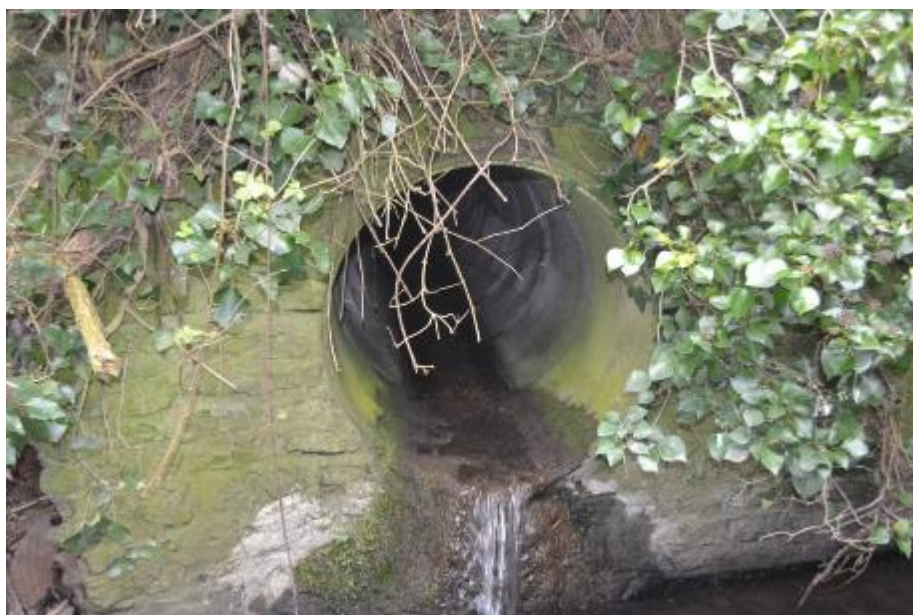
Figure 56: A 90cm diameter pipe, located on the left bank, discharging effluent into Keward Brook approximately 75m downstream of survey point KB11. The effluent was odourless and clear at the time this image was taken.

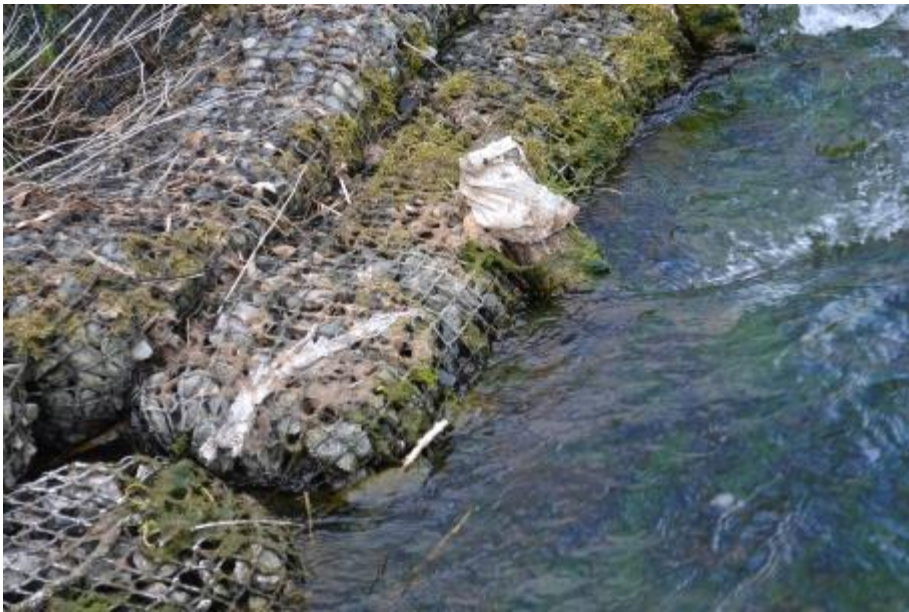
Figure 75: Litter along left bank of Keward Brook, approximately 15m downstream of survey point KB16.

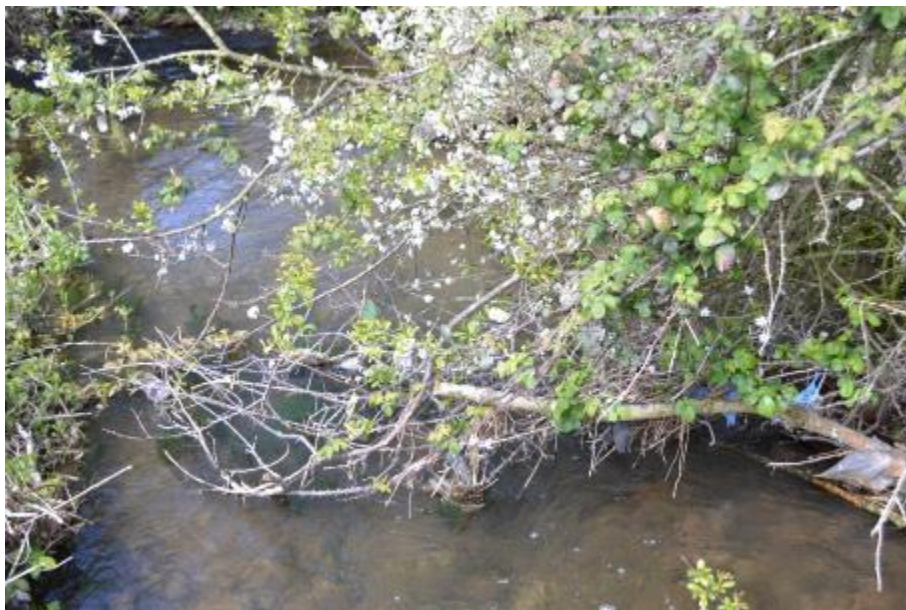
Figure 77: Downstream view of Keward Brook approximately 80m downstream of survey point KB16. Note the litter present along the right bank.

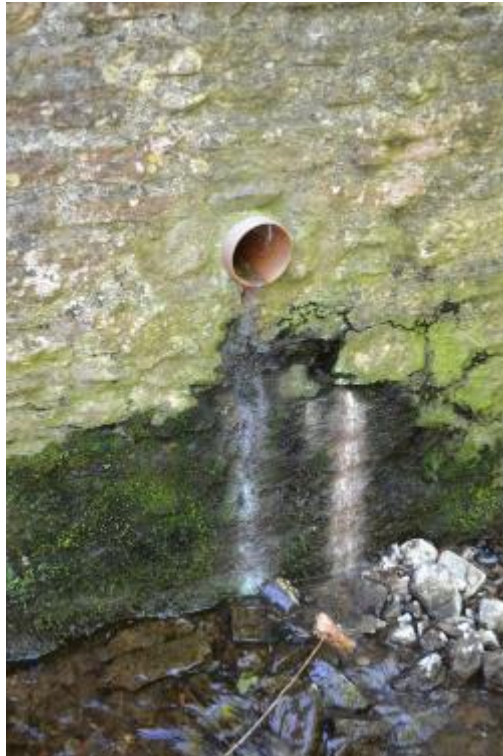
Figure 80: A 15cm diameter pipe located on the left bank wall of Keward Brook at survey point KB17. Note the prominent staining on the wall caused by the discharge of effluent from the pipe.

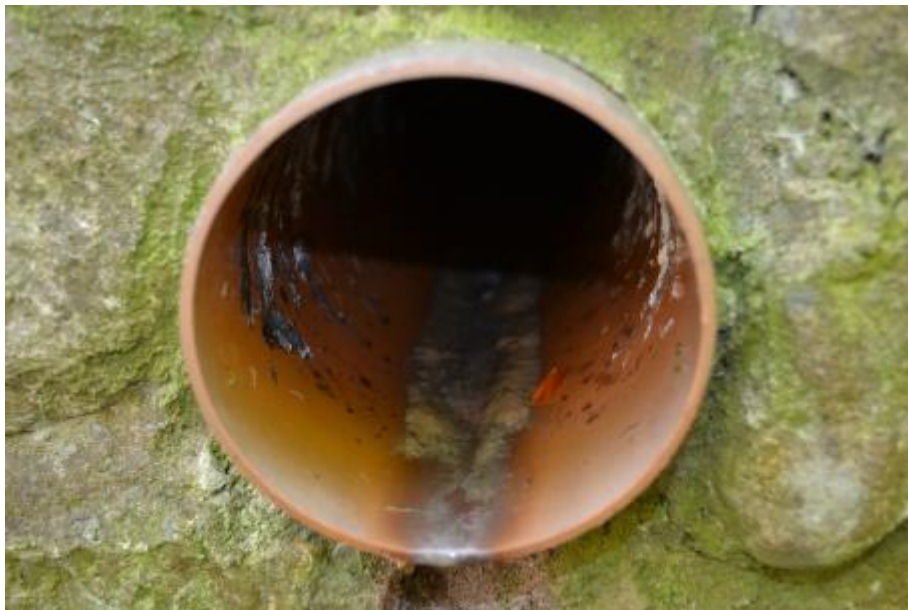
Figure 81: Close up view of the 15cm diameter pipe located on the left bank wall of Keward Brook at survey point KB17. Effluent is clearly visible in the pipe the pipe; a foul smelling odour was present.

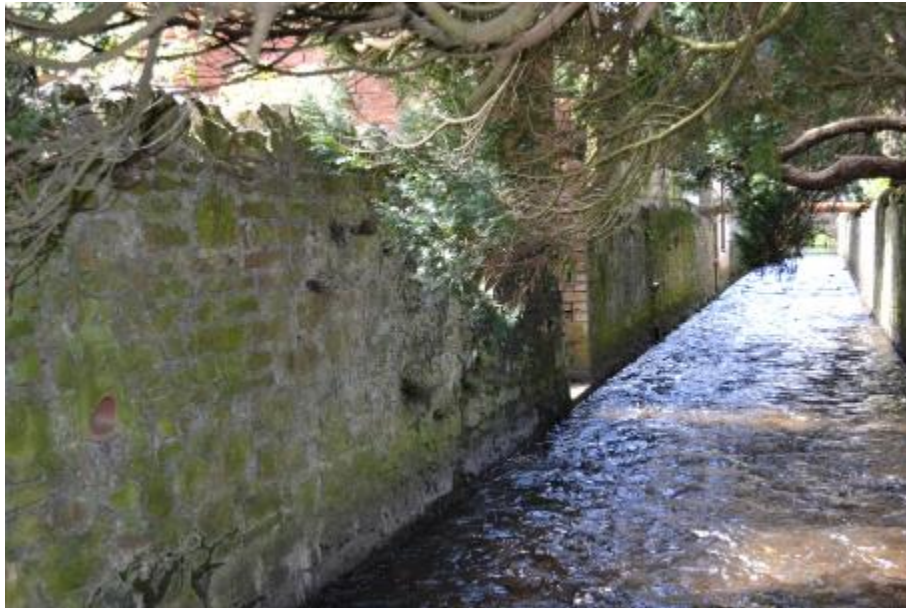
Figure 82: Downstream view of Keward Brook, approximately 40m downstream from survey point KB17. Note the presence of several (five in total) 15cm diameter discharge pipes located along the left bank wall. No staining was visible on the wall below any of these pipes and no foul smelling odour was present.

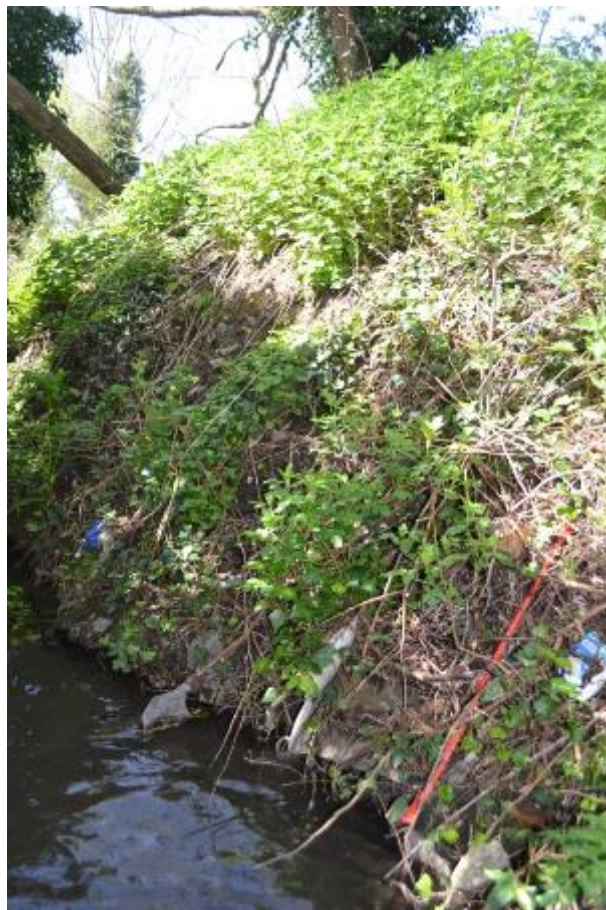
Figure 123: Litter visible in the right bank vegetation of St. Andrew's Stream 50m downstream from survey point SA7a.
