Observation Survey of Keward Brook, St Andrew's Stream and St. Thomas's Stream, located in Wells Somerset

– Conducted by Teleost Consulting on behalf of Wells Civic Society

09/05/2016

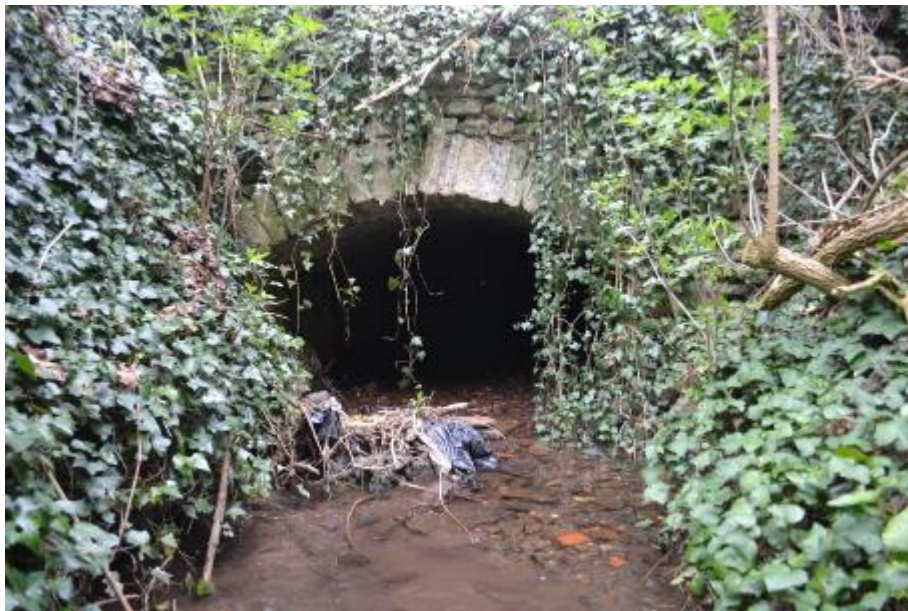
The Brook begins close to Wells Moat where it appears from the tunnel displayed in Figure 5. The brook passes through a gully that is vegetated by a simple vegetation structure (Figure 6). The substrate was found to consist predominantly of cobble (Figure 7). Notable amounts of litter were present at, and downstream of, this survey point (Figure 7).

Figure 5: Upstream view of Keward Brook from survey point KB1.

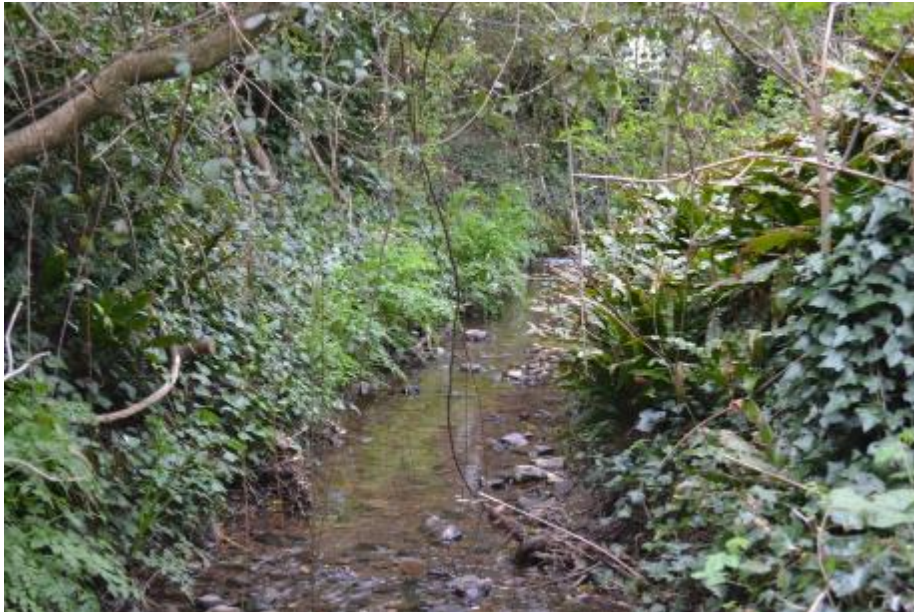
Figure 6: Downstream view from view of Keward Brook from survey point KB1.

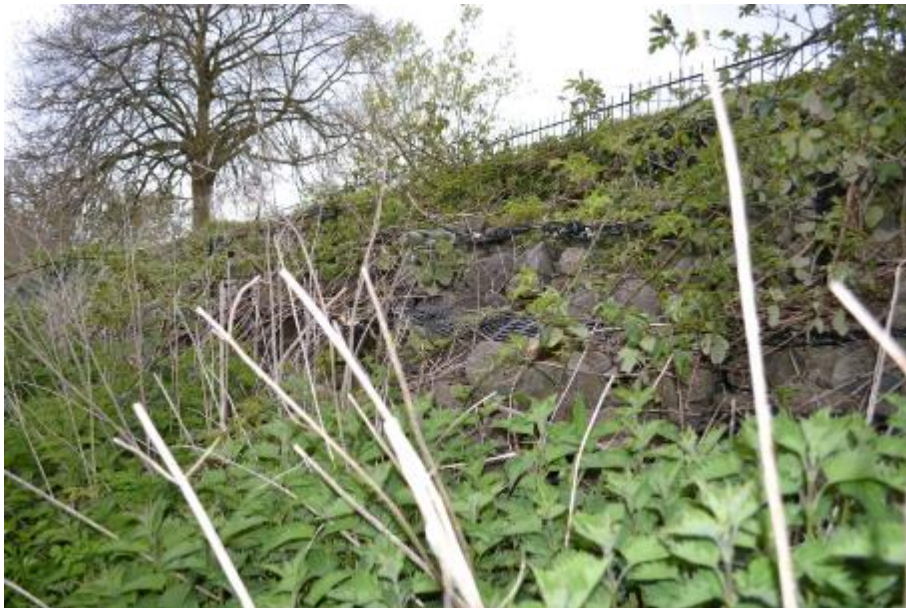
The surrounding land use is classed as sub-urban/urban (asphalt footpath) to the right bank and unimproved grassland to the left bank. Additional water enters the brook directly from the moat via the pipe displayed in Figure 8. Downstream of this pipe, modifications (stone bank reinforcement) are visible on the right bank (Figure 9). Downstream of this pipe the bankside vegetation becomes overgrown with the stream barely visible (Figure 10).

Figure 9: View of stone reinforcement of right bank of Keward Brook approximately 65m downstream of survey point KB1.

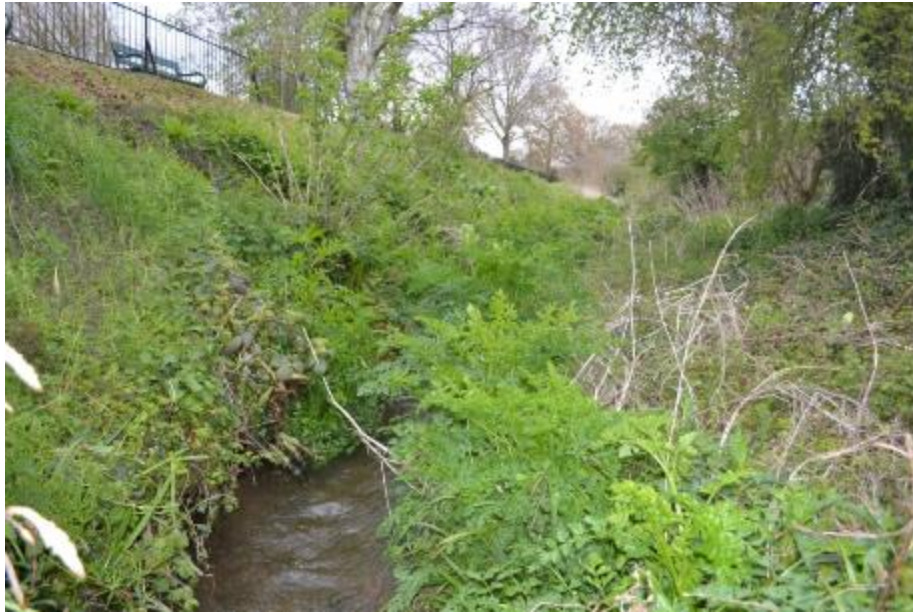
The brook continues through a gully that is vegetated by a simple vegetation structure (Figure 11 and Figure 12). Notable amounts of litter were present at, and downstream of, this survey point. The surrounding land use is classed as sub-urban/urban (asphalt footpath) to the right bank and unimproved grassland to the left bank.

Figure 11: Upstream view of Keward Brook from survey point KB2.

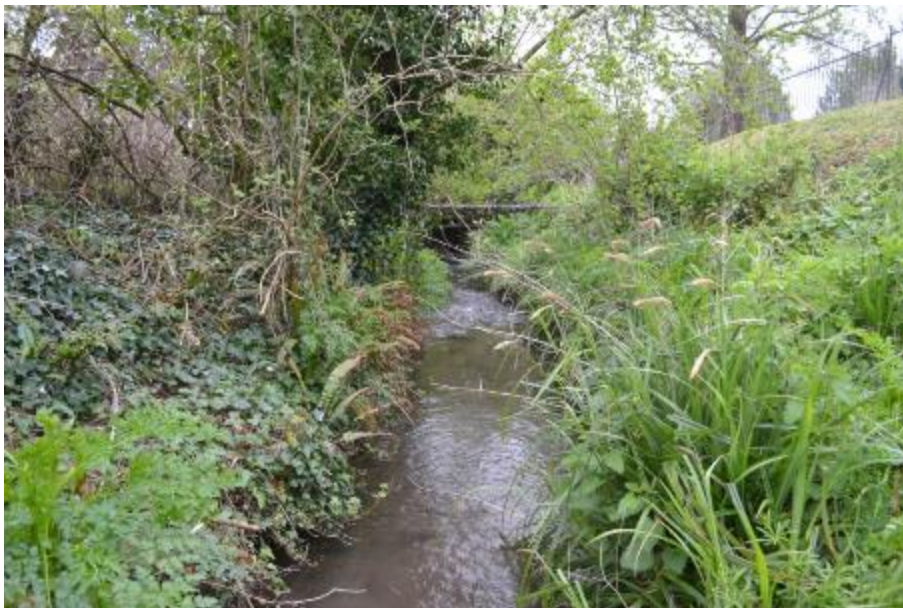
Figure 12: Downstream view of Keward Brook from survey point KB2.

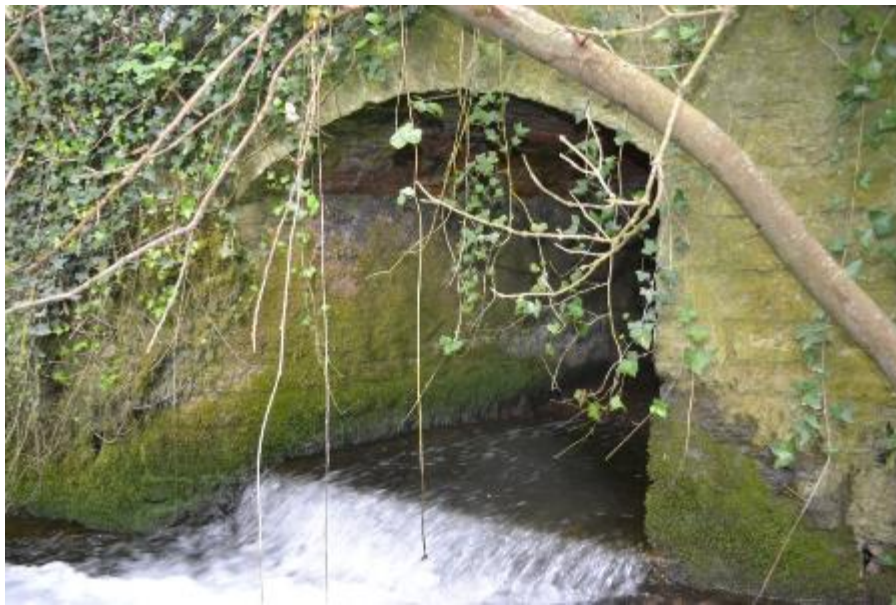
Slightly downstream of the metal bar is the main outfall where water from Wells Moat flows into Keward Brook (Figure 14Figure 15).

Figure 14: Main outflow from moat on the right bank of Keward Brook approximately 30m downstream of survey point KB2.

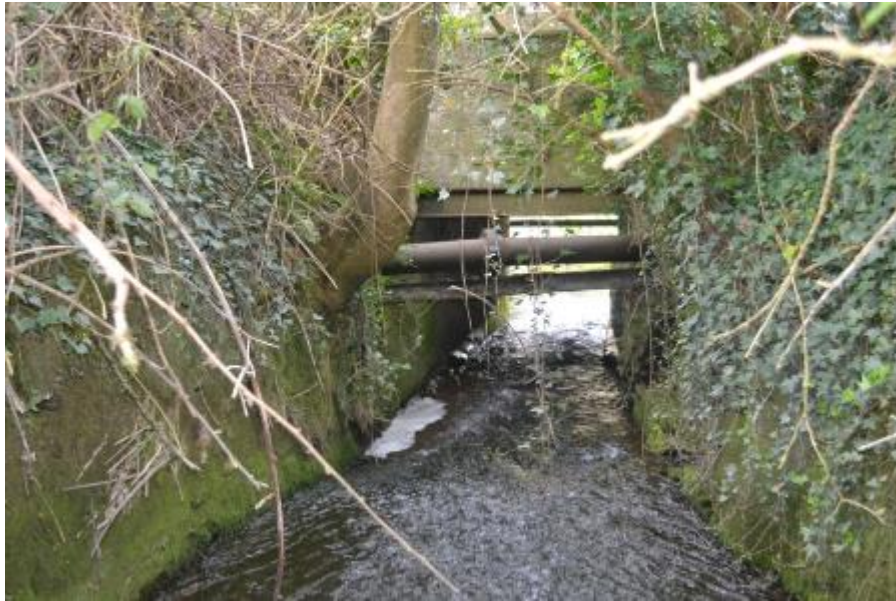
Figure 15: View downstream at the outflow from Wells Moat, approximately 30m downstream of survey point KB2.

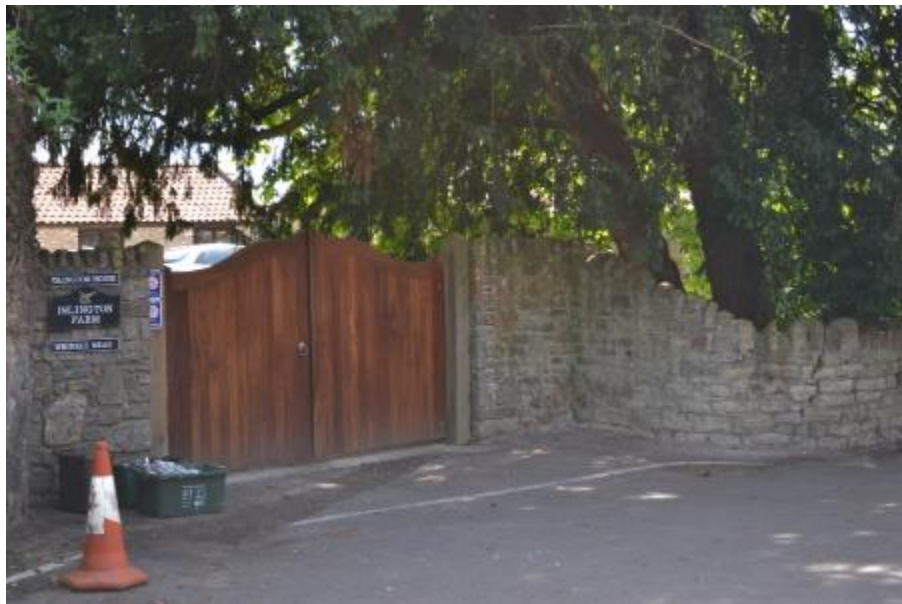
At survey point KB3 the brook passes through the private grounds of a guest house (Figure 16).

Figure 16: Guest house at survey point KB3. Keward Brook runs immediately the other side of, and parallel to, the brick wall.

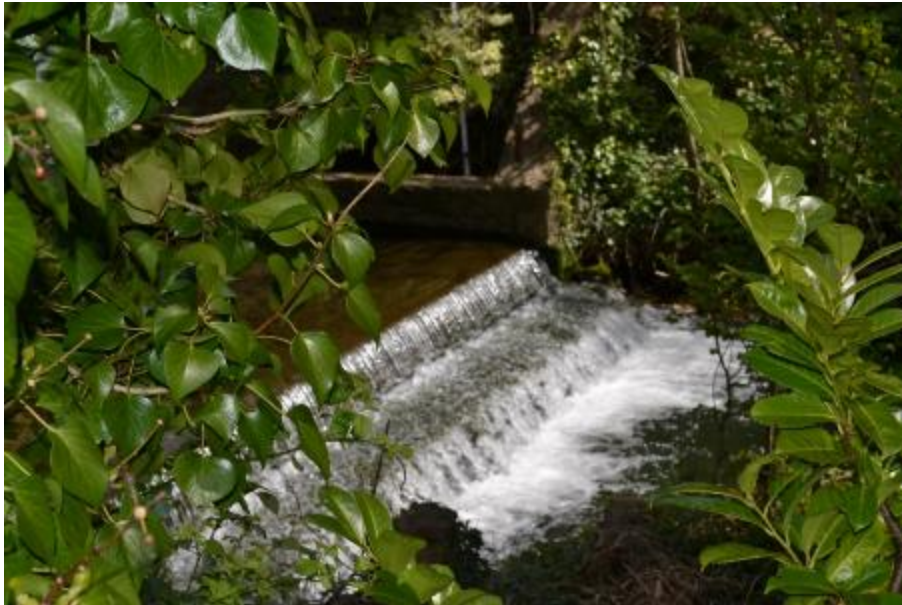
A weir is visible over the right bank wall, located approximately 50m downstream of survey point KB3 (Figure 17). This weir is within the grounds of the guest house.

Figure 17: View of weir from right bank, approximately 50m downstream of survey point KB3.

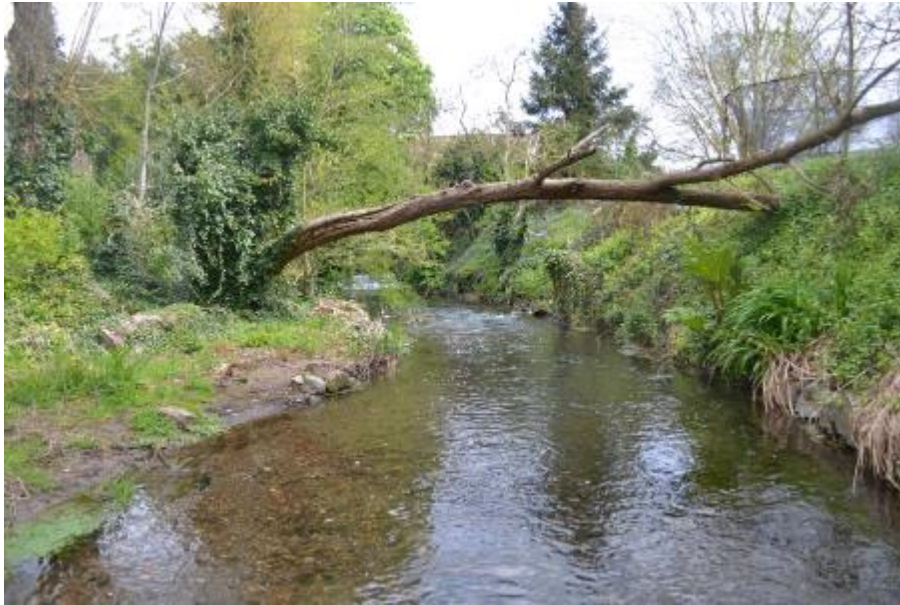
The brook flows through the grounds of private house situated on the left bank. Upstream of survey point KB4 the brook flows through the garden of the house where it is well maintained and visually attractive (Figure 18). Downstream the brook has a more natural appearance and flows over small riffles which occasionally flow into a pool (Figure 19).

Figure 18: Upstream view of Keward Brook from survey point KB4.

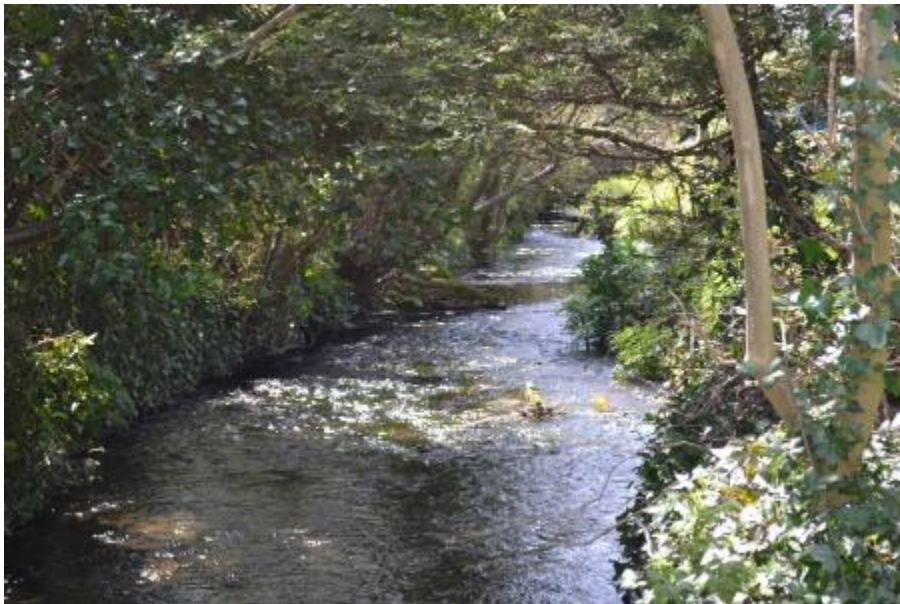
Figure 19: Downstream view of Keward Brook from survey point KB4.

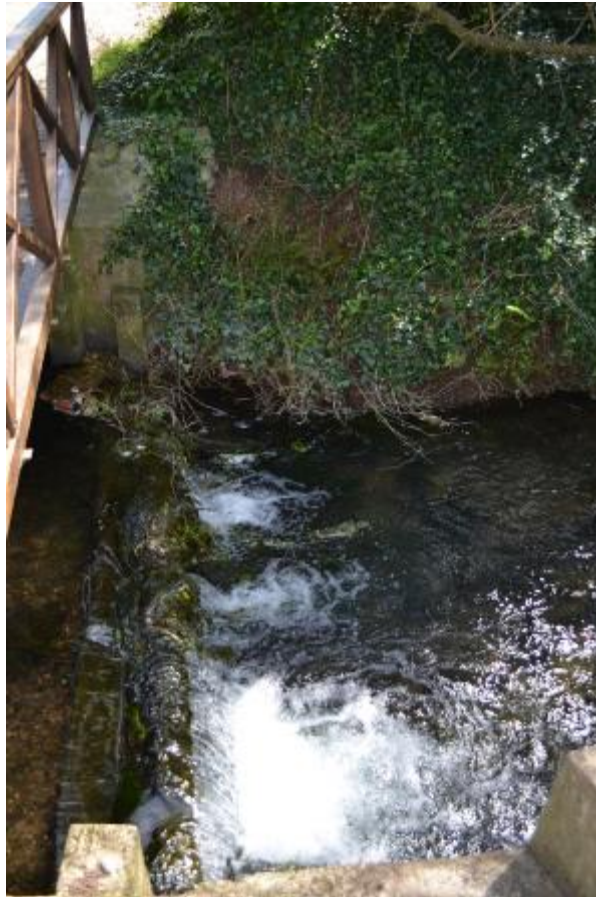
A small weir is present at the survey point which can be found under the bridge leading to the private residence (Figure 20). Metal stakes can be seen placed along the bank approximately 15m downstream of survey point KB4 (Figure 21). The reason for their presence is unknown.

Figure 20: View of weir from the right bank at survey point KB4.

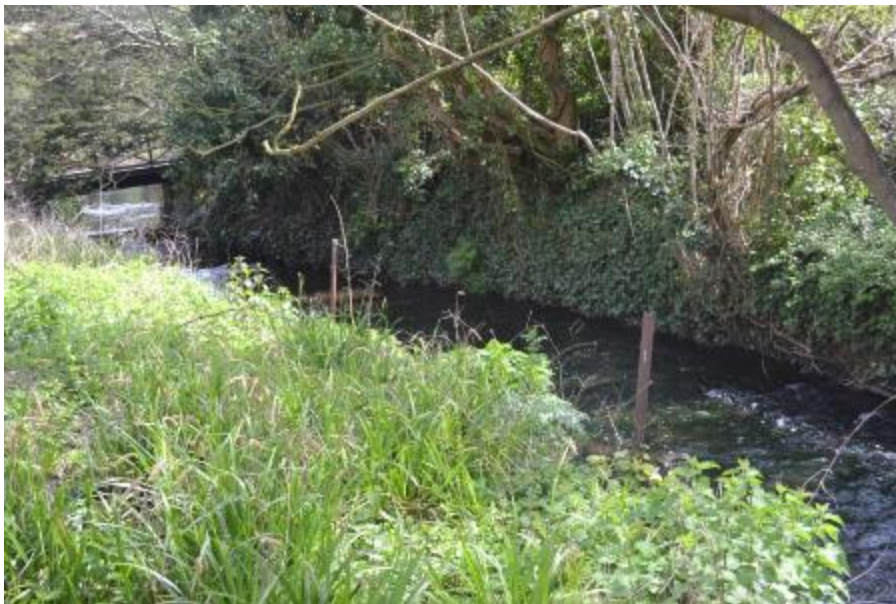
Figure 21: Upstream view of Keward Brook from the right bank, approximately 15m downstream of survey point KB4. Note the metal stakes along the right bank margin.

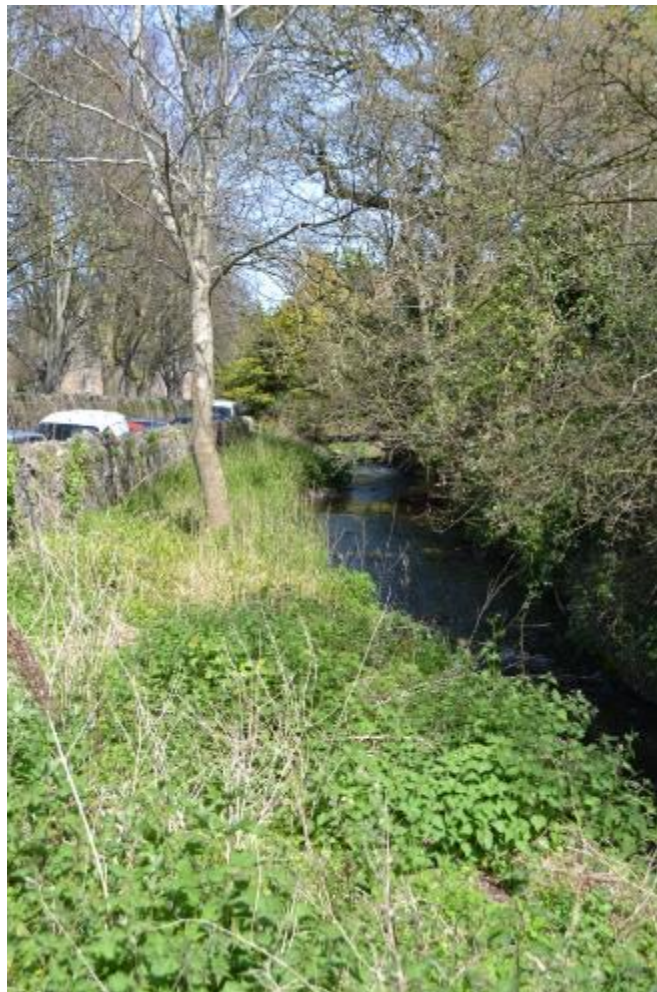
Immediately upstream the right bank forms a flat grass area comprising of a simple vegetation structure (Figure 22). This area can be accessed by the gate displayed in Figure 23 which is located approximately 20m upstream of survey point KB5. The gate is padlocked which prevents public access.

Figure 22: Upstream view of Keward Brook from survey point KB5.

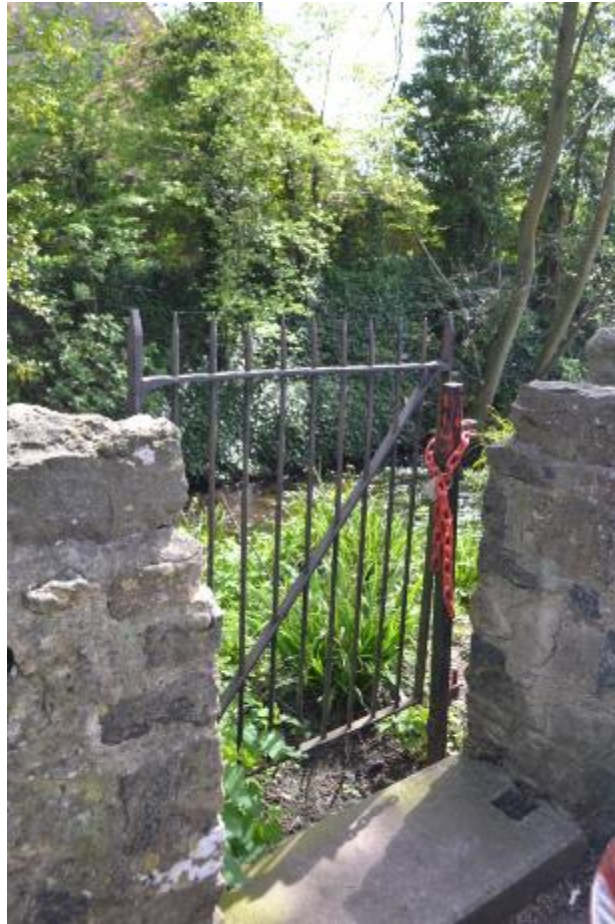
Figure 23: Access to the right bank of Keward Brook, approximately 20m upstream of survey point KB5.

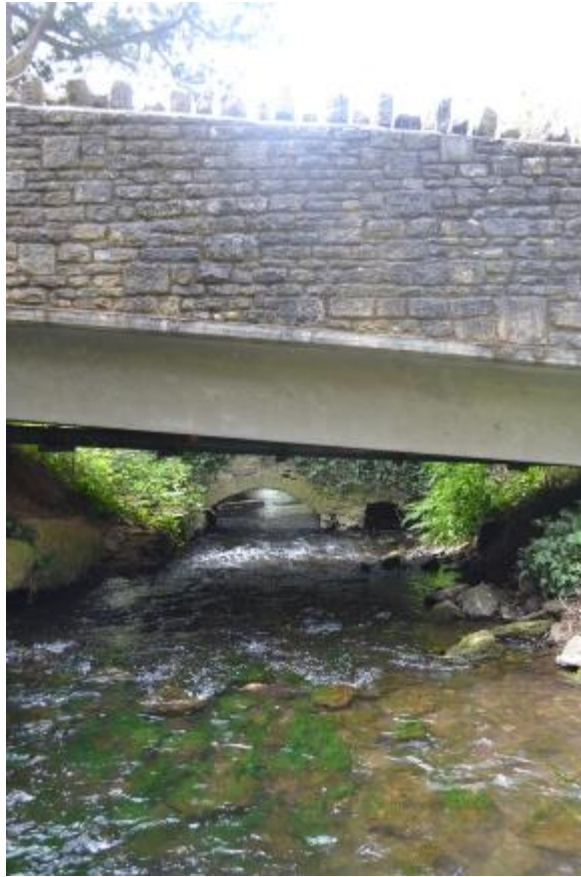
Figure 24: Downstream view of Keward Brook from survey point KB5.

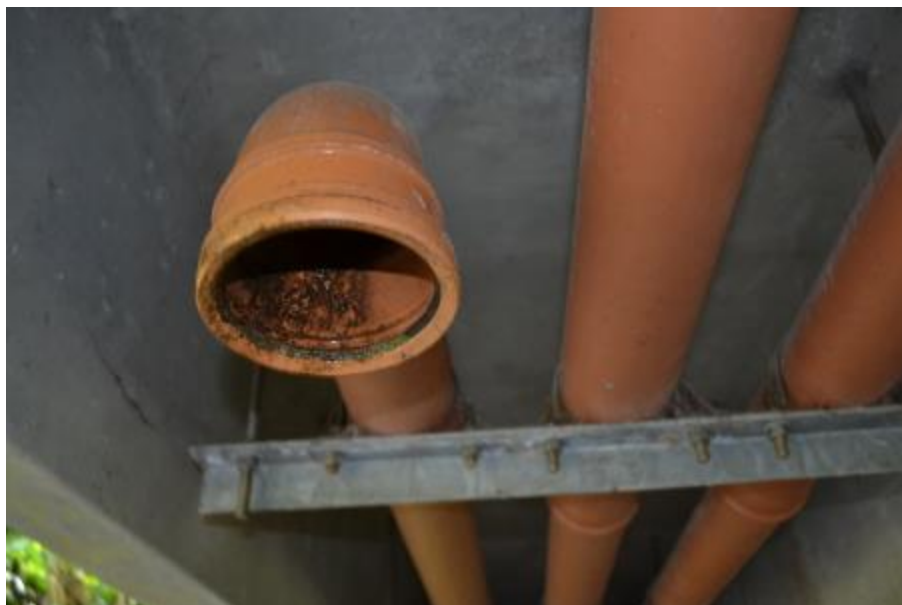
Downstream the brook passes under a series of three access bridges. An effluent discharge pipe was found to be located under the first bridge (Figure 25). The pipe points downwards and empties directly into the brook. Although no odour was present at the time of the survey it should be noted that it services agricultural operations along the left bank of the brook.

Figure 25: Pipe under the first bridge located downstream of survey point KB5. The 15cm diameter pipe runs from the left bank and dispenses directly into Keward Brook. No odour was present, although brown residue can be clearly visible close to the exit.

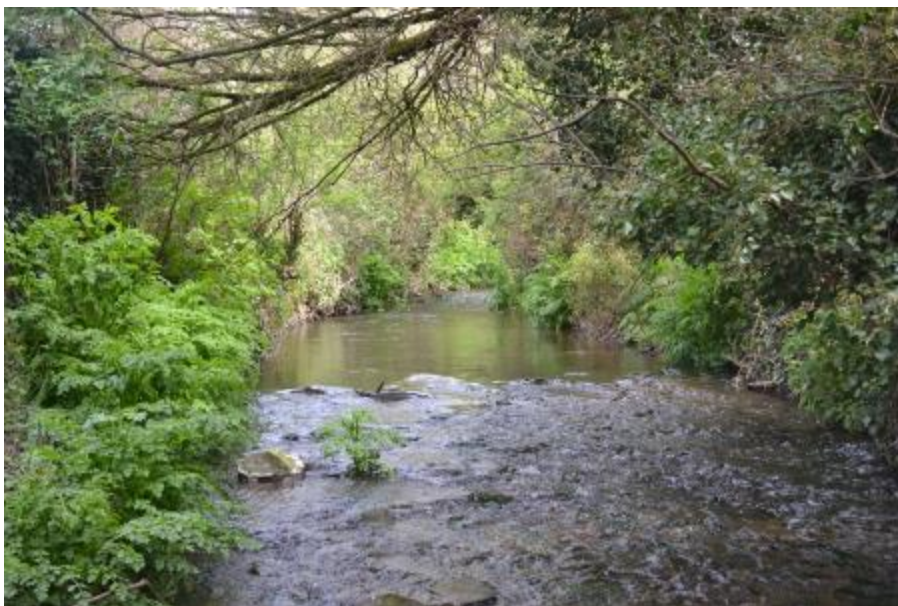
Figure 27: Upstream view of Keward Brook from survey point KB6.

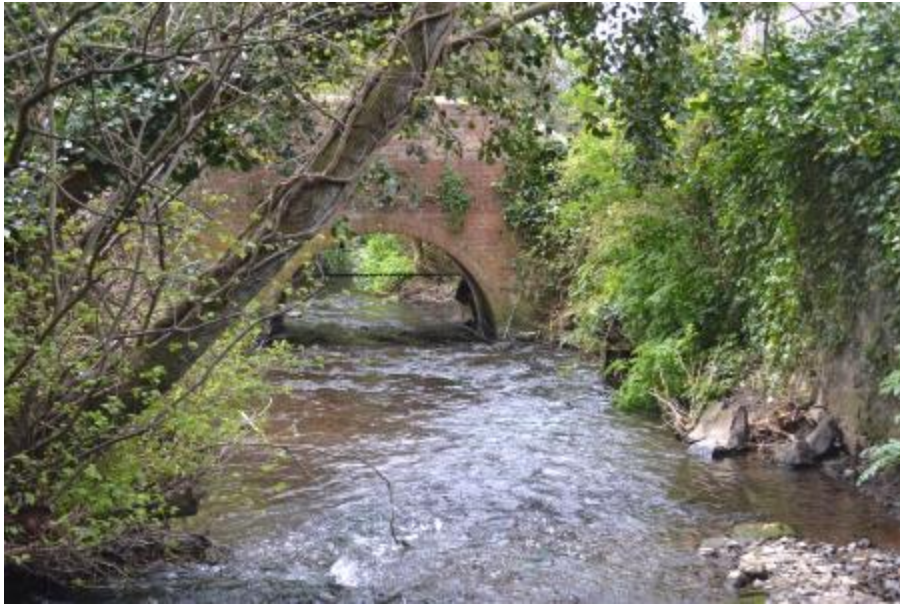
Figure 28: Downstream view of Keward Brook from survey point KB6.

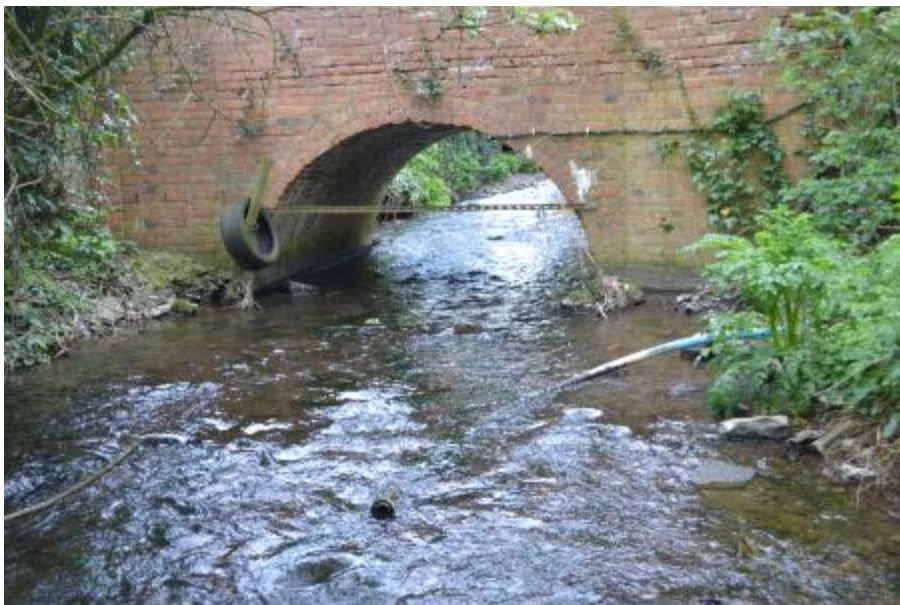
Figure 29: Upstream view of bridge approximately 15m downstream of survey point KB6. Note the metal bar running across the bridge arch, a stake supporting a tyre on the right bank (left in the image) and a blue pipe running into the stream.

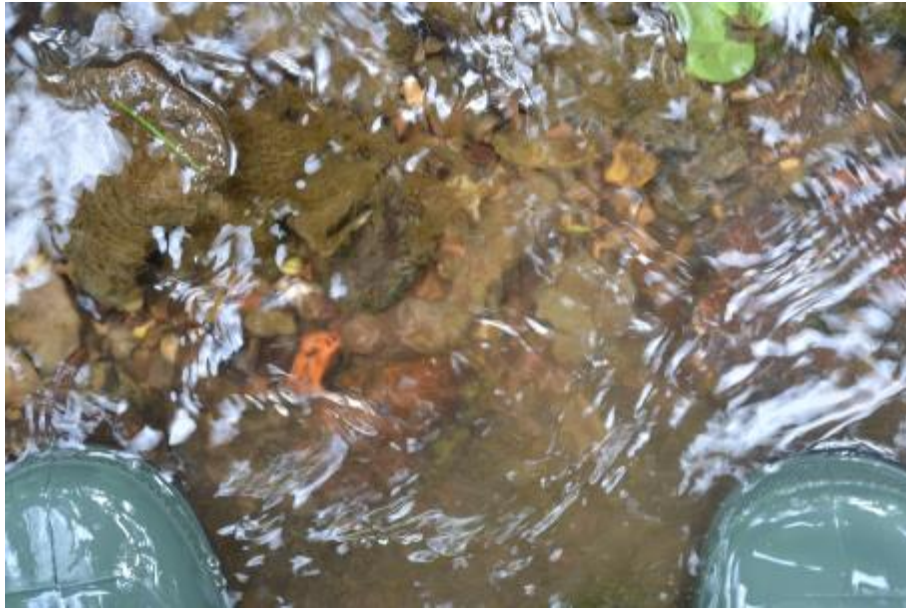
Figure 30: The streambed substrate present at survey point KB6.

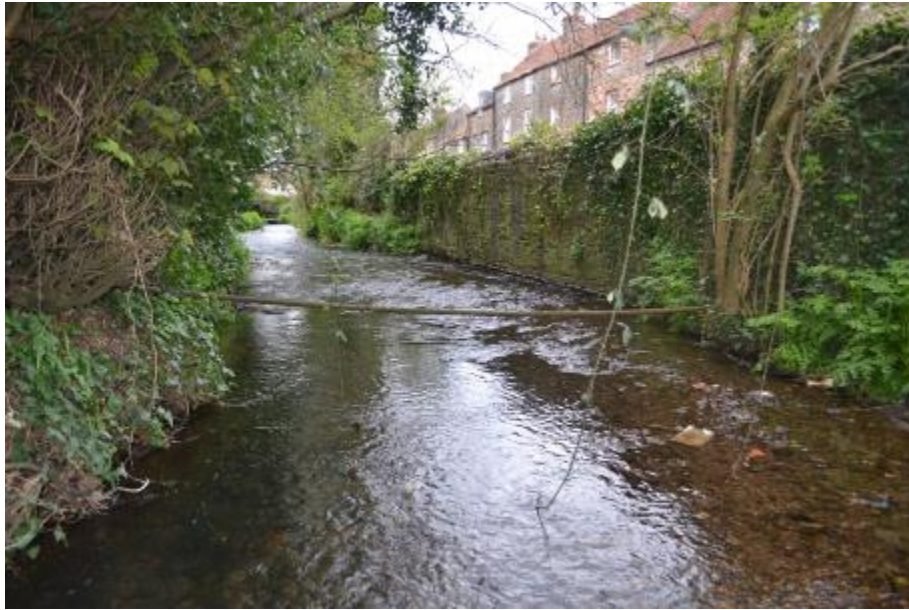
Figure 32: Downstream view of Keward Brook approximately 50m downstream of survey point KB6. Note the high wall running parallel to the right bank and the pipe bridging across the channel.

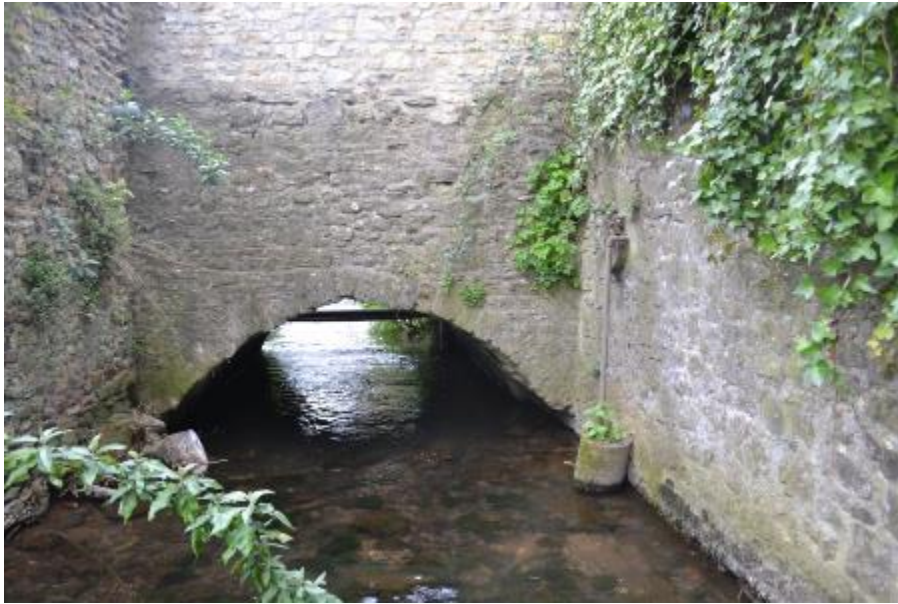
Figure 34: Upstream view of Keward Brook from survey point KB7.

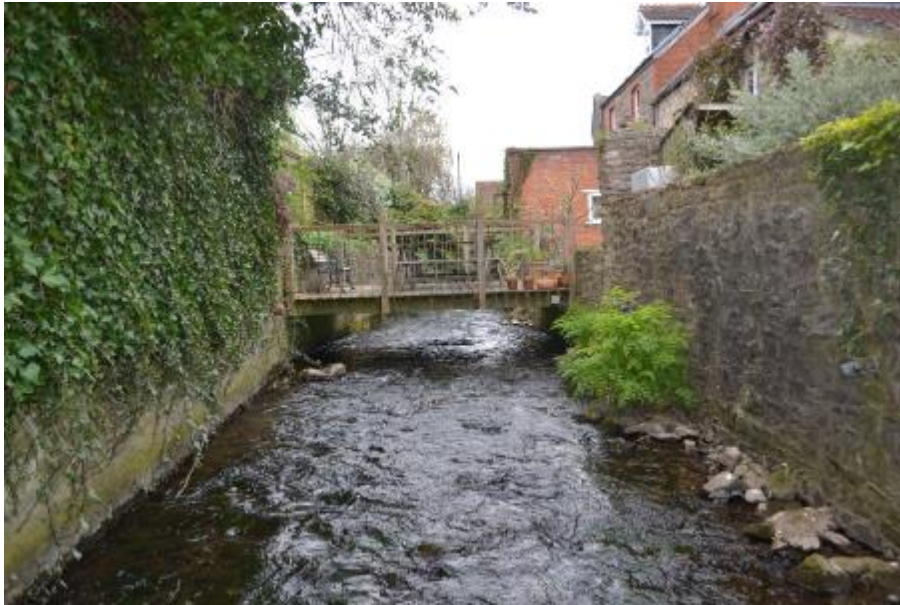
Figure 36: Downstream view of Keward Brook from survey point KB7.

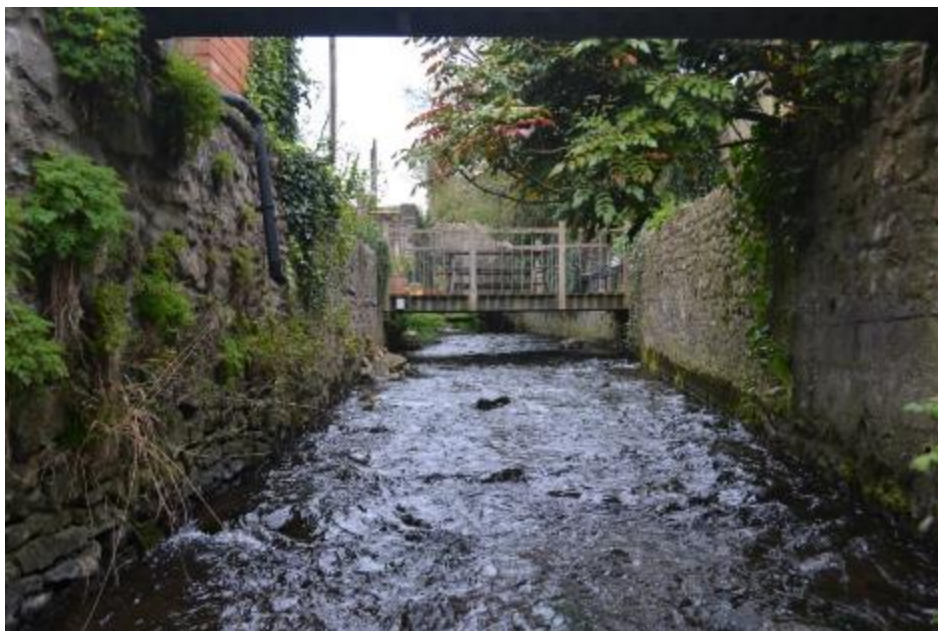
Figure 37: Upstream view of Keward Brook from survey point KB8.

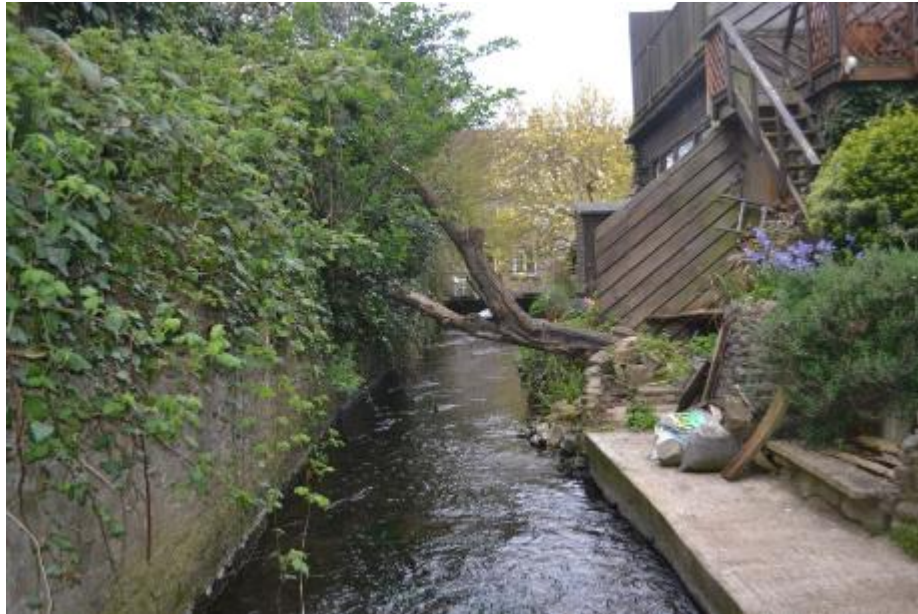
Figure 38: Downstream view of Keward Brook from survey point KB8.

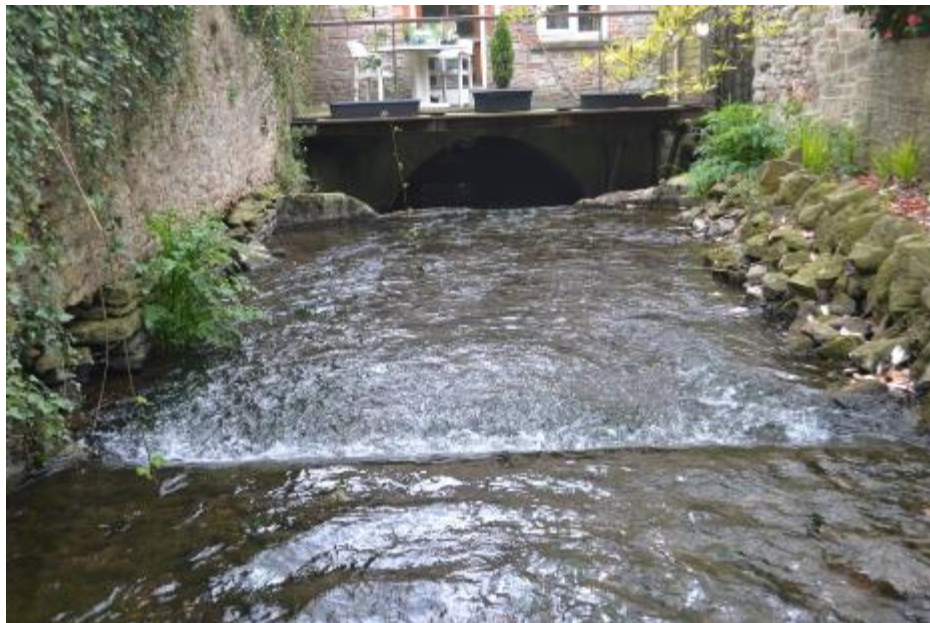
Figure 39: Weir approximately 40m downstream of survey point KB8.

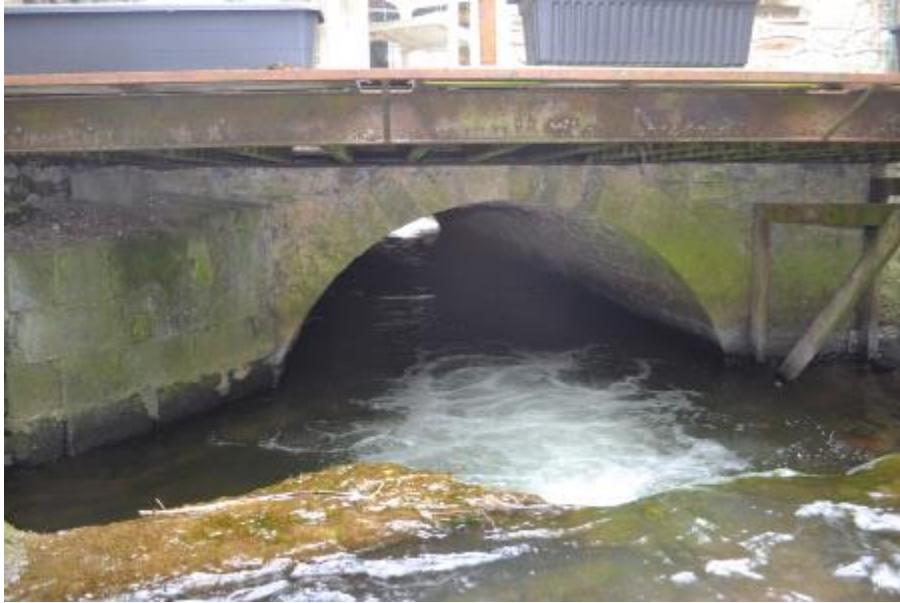
Figure 40: Downstream view of weir pool and tunnel that pass below a house built over Keward Brook, located approximately 40m downstream of survey point KB8.

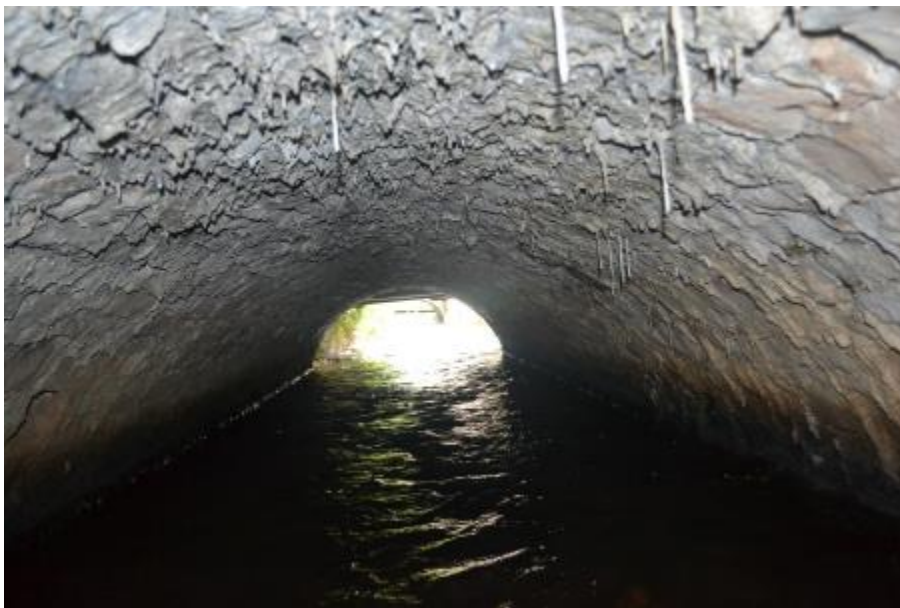
Figure 41: Downstream view within the tunnel that passes below a house built over Keward Brook, located approximately 45m downstream of survey point KB8.

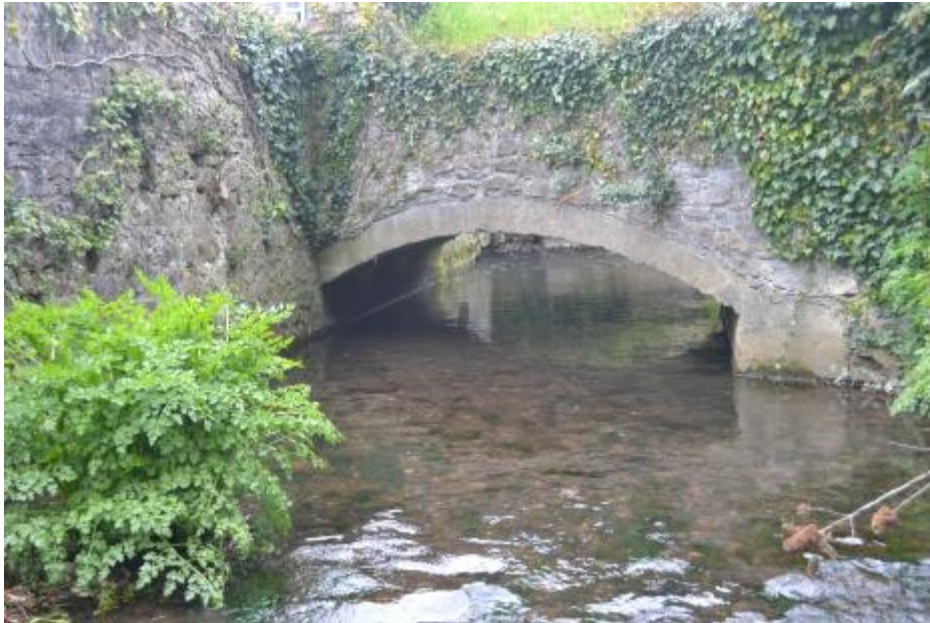
Figure 42: Upstream view of Keward Brook from survey point KB9.

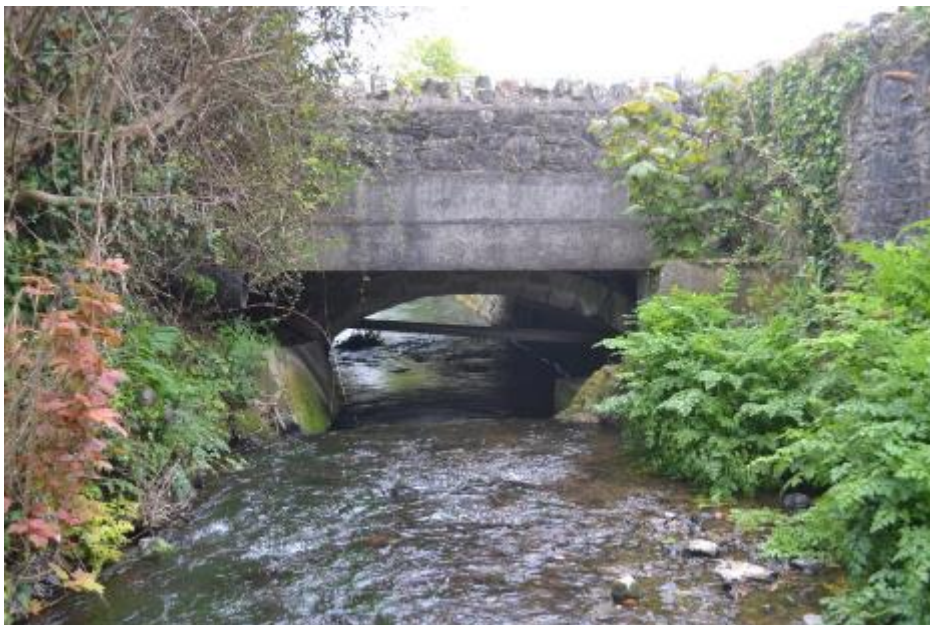
Figure 43: Downstream view of Keward Brook from survey point KB9.

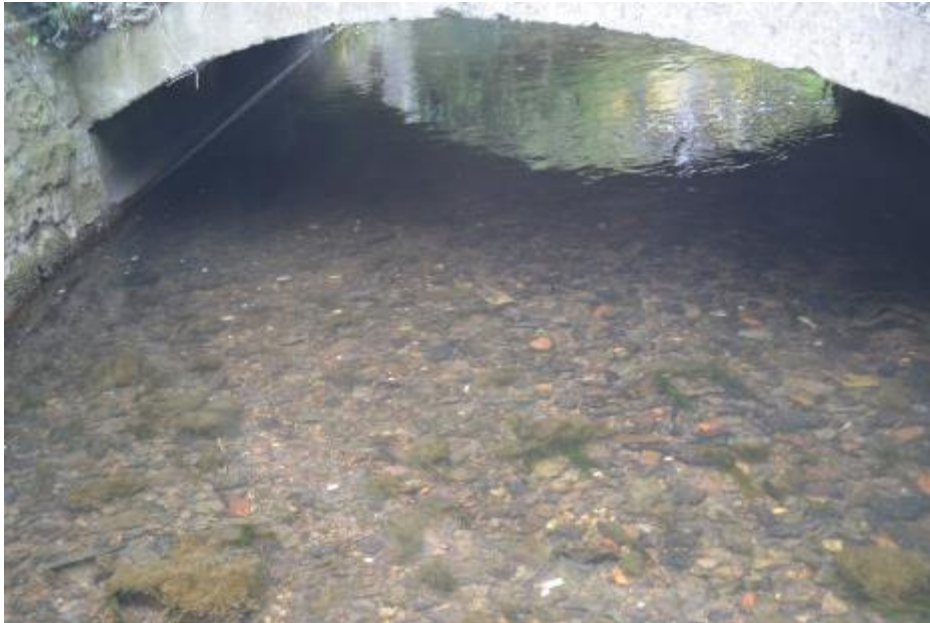
Figure 44: Keward Brook stream bed substrate present at survey point KB9.

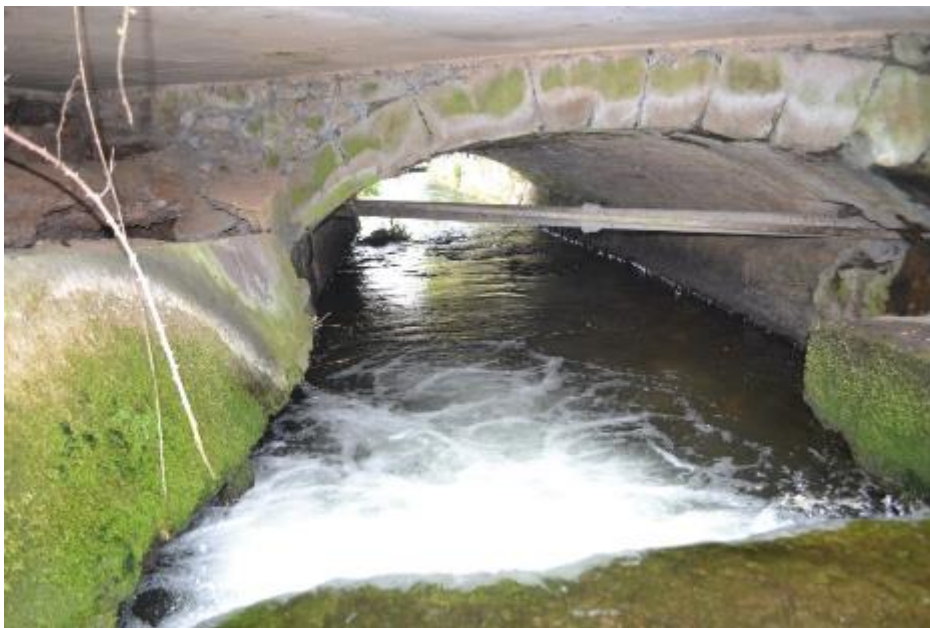
Figure 45: Downstream view of weir located approximately 10m downstream of survey point KB9.

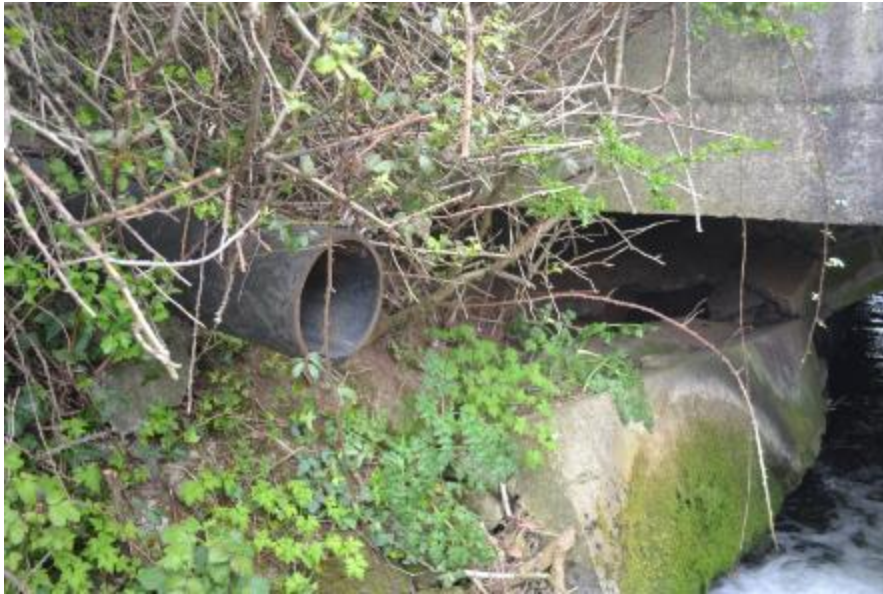
Figure 46: Discharge pipe located 10m downstream of survey point KB9 on the left bank. The 24cm diameter pipe was odourless and was not discharging effluent.

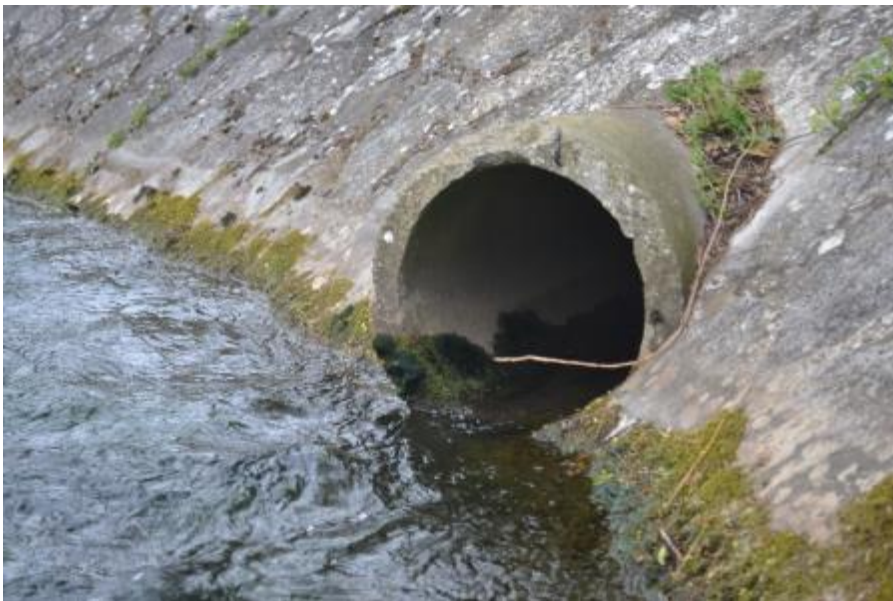
Figure 51: A 50cm diameter pipe, located on the left bank, discharging effluent into Keward Brook approximately 20m upstream of survey point KB11. The effluent was odourless and clear at the time this image was taken.

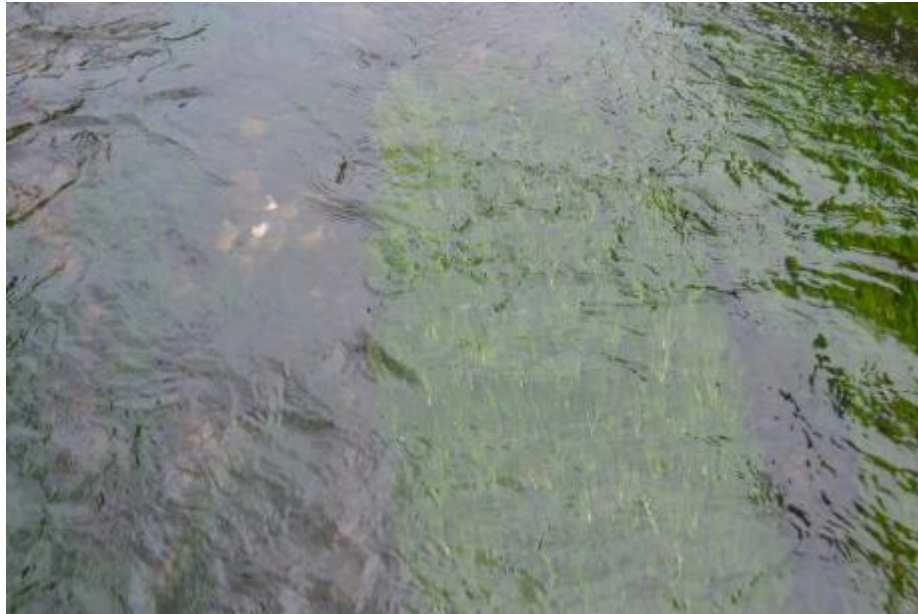
Figure 54: Substantial weed beds (*Ranunculus* sp.) that are present at survey point KB11 downstream to the end of Gate Lane.

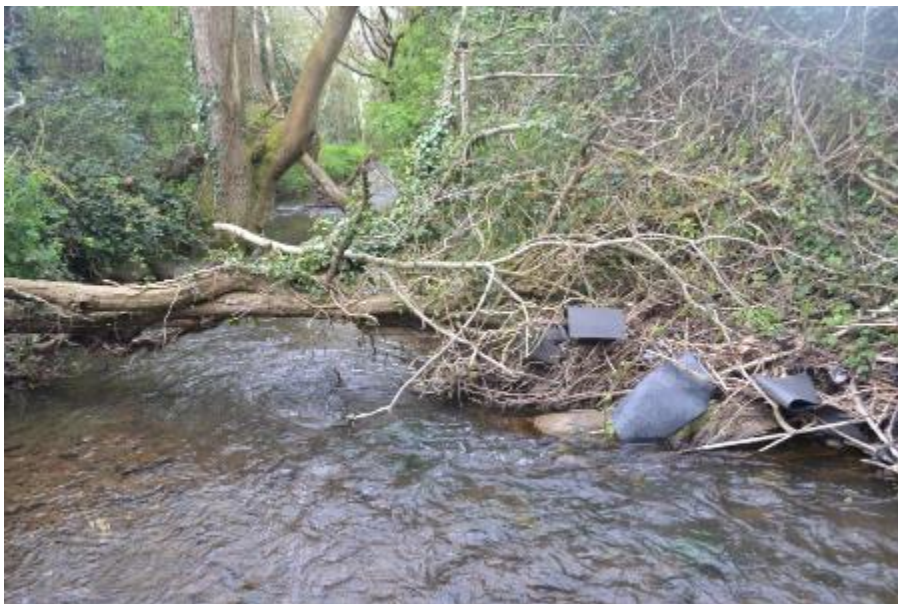
Figure 63: Debris behind a tree that has fallen from the left bank, approximately 50m downstream of survey point KB13.

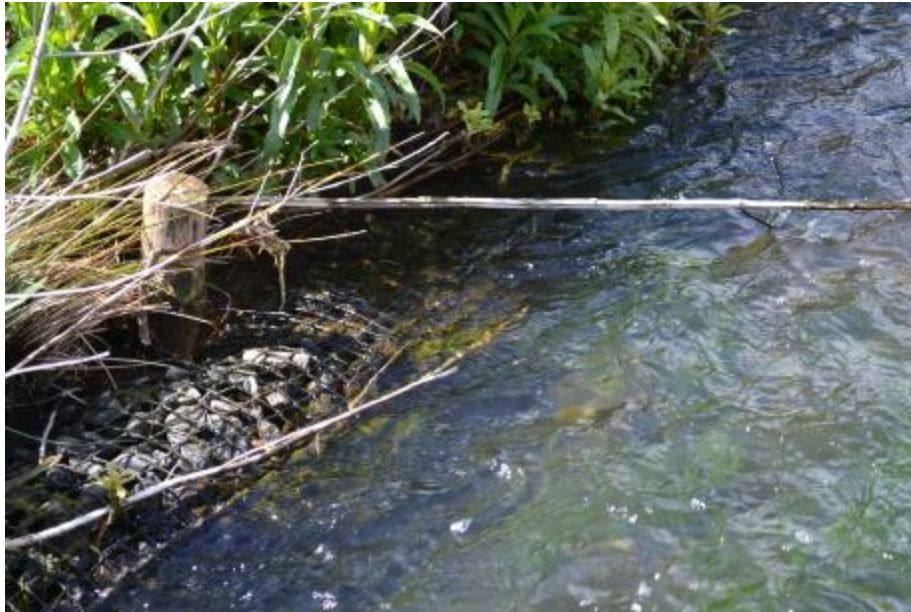
Figure 70: Rock and coir rolls placed situated along the left bank of Keward Brook, approximately 50m downstream from survey point KB15.
