Observation Survey of Keward Brook, St Andrew's Stream and St. Thomas's Stream, located in Wells Somerset

– Conducted by Teleost Consulting on behalf of Wells Civic Society

09/05/2016

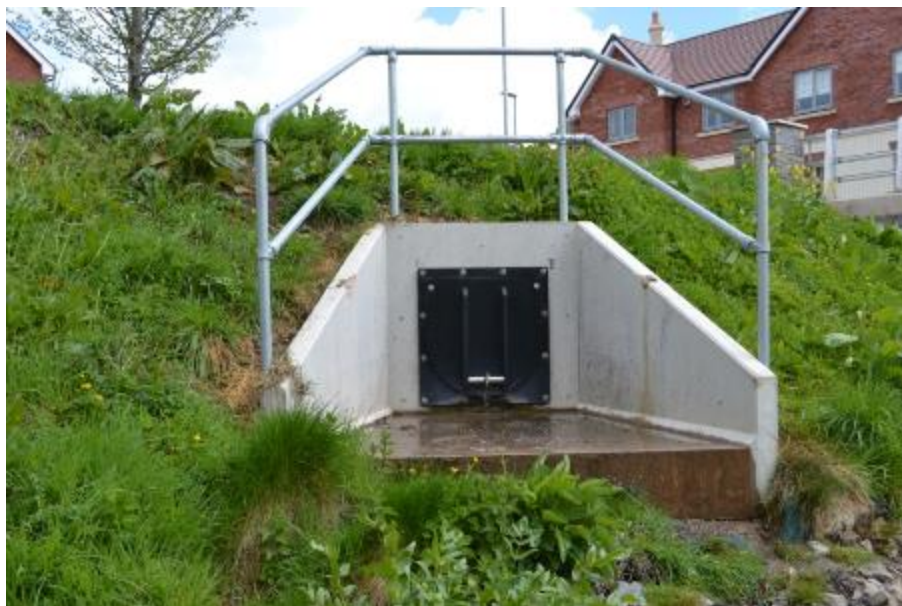
Figure 71: A 50cm diameter surface water drainage discharge pipe situated on the right bank of Keward Brook, approximately 80 m downstream of survey point KB15.

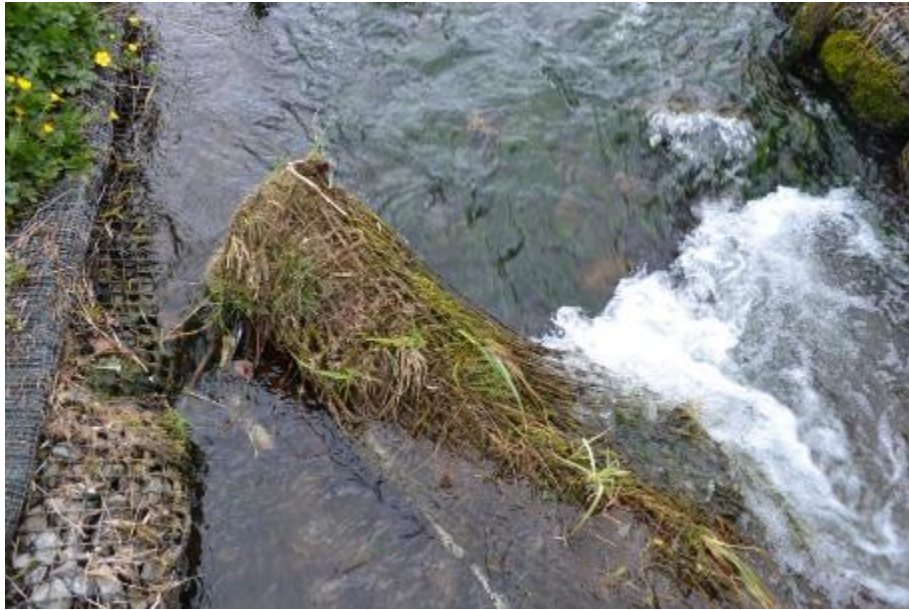
Figure 74: Upstream view of a flow deflector located on the right bank, approximately 10m downstream from survey point KB16.

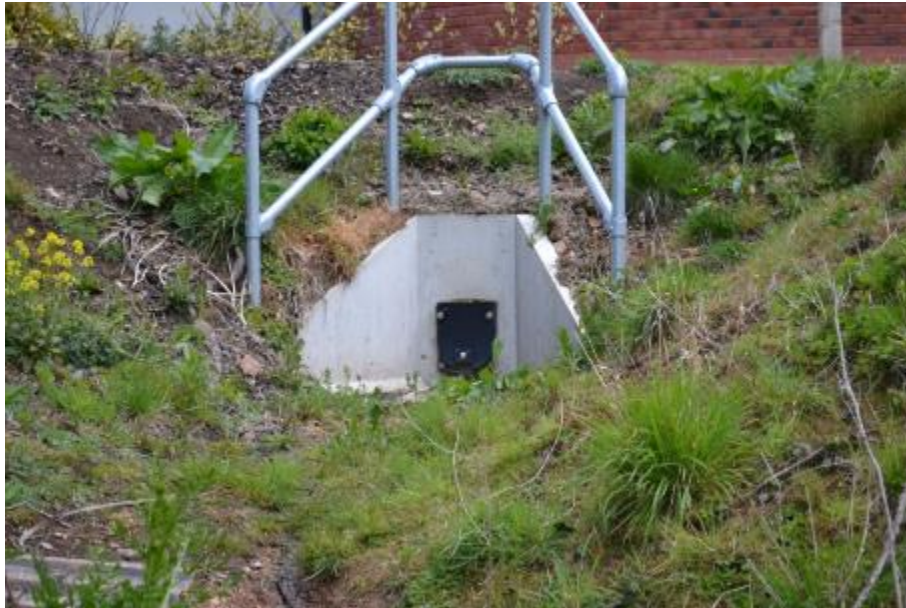
Figure 76: A 15cm diameter surface water drainage discharge pipe situated on the right bank of Keward Brook, approximately 75m downstream of survey point KB16.

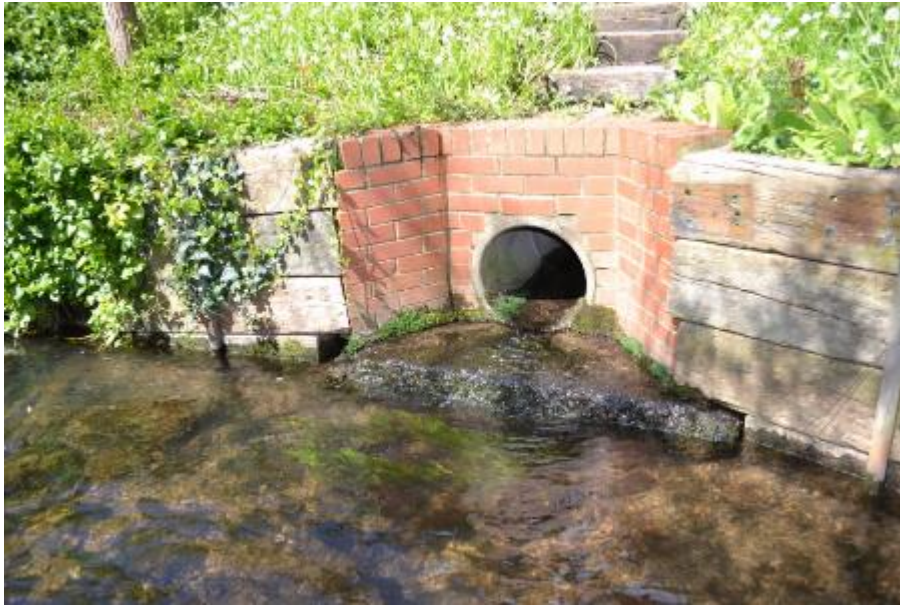
Figure 86: A 45cm diameter culvert pipe discharge pipe situated on the right bank of Keward Brook, approximately 75m downstream of survey point KB18. The pipe was discharging a constant flow of clear, odourless water, possibly flowing from St. Andrew's Stream.

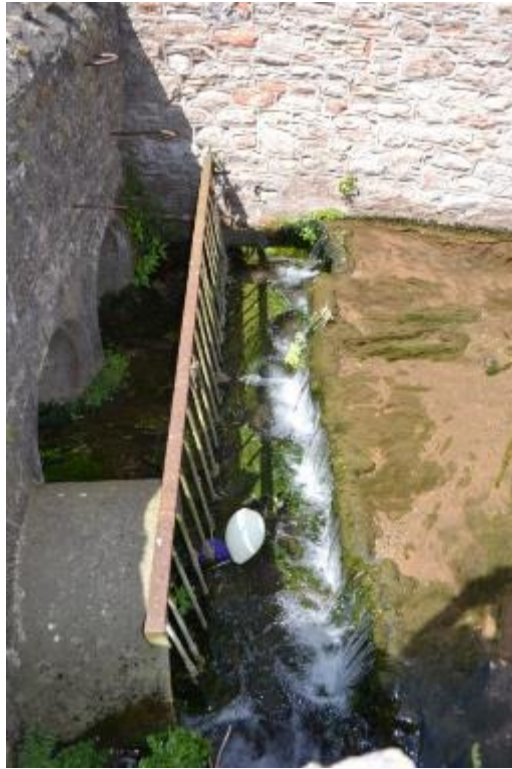
Figure 98: Weir, culvert pipes and litter at survey point SA1.

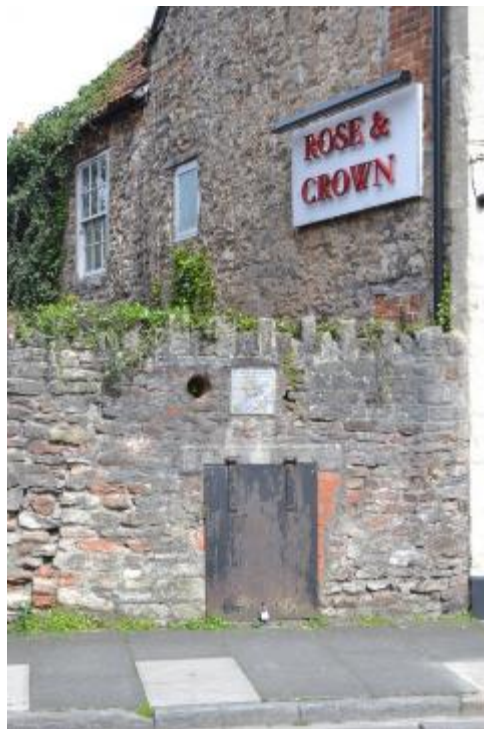
Figure 99: Wall at survey point SA2 behind which runs St. Andrew's Stream. The Stream runs from towards the pavement and is culverted from this point to survey point SA3

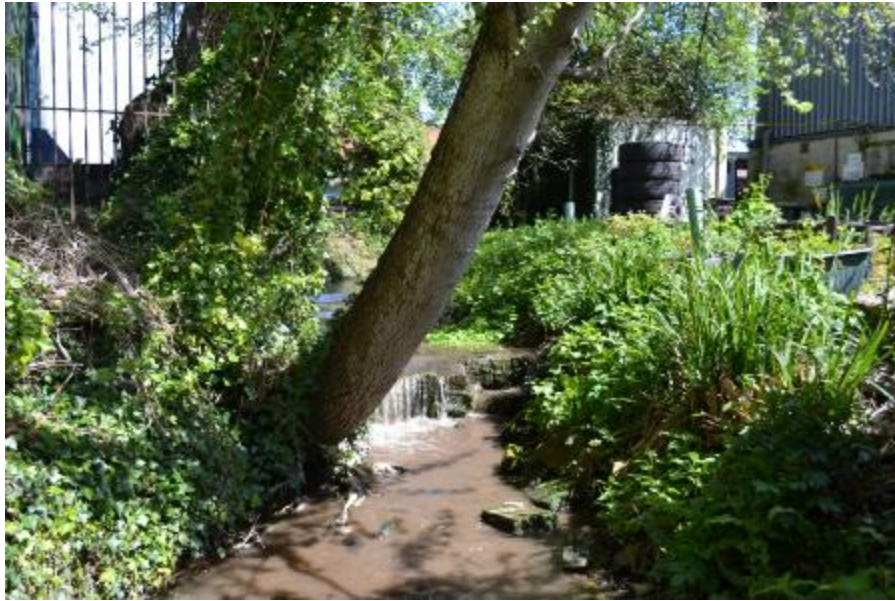
Figure 104: Upstream view of St. Andrew's Stream and small weir approximately 20m downstream of survey point SA3.

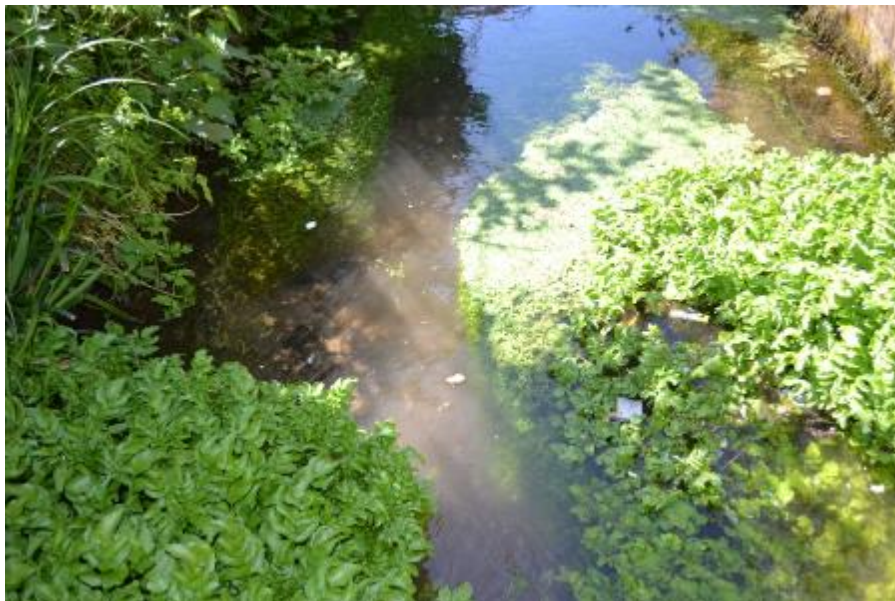
Figure 105: Substantial weed growth in the channel of St. Andrew's Stream approximately 50m downstream of survey point SA3.

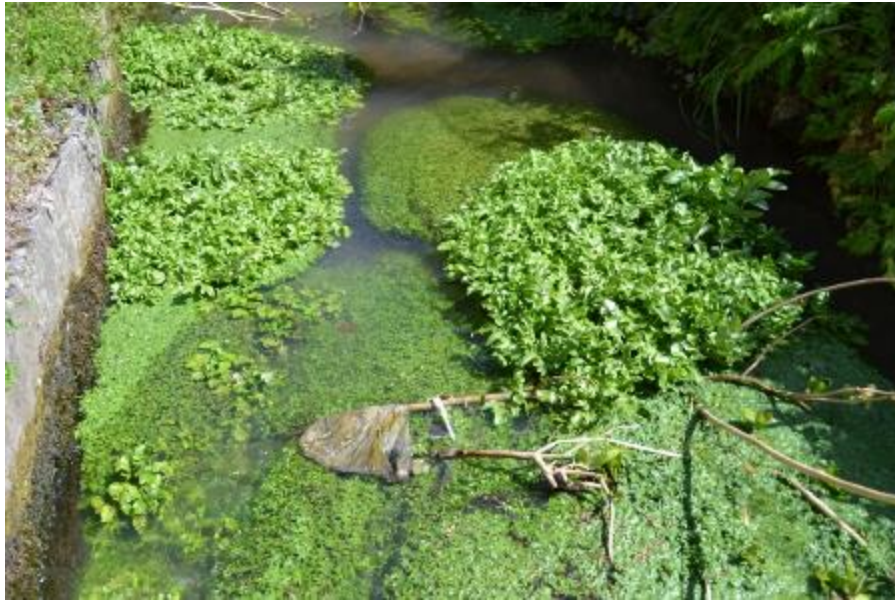
Figure 108: Substantial weed growth and litter in the channel of St. Andrew's Stream approximately 50m downstream of survey point SA4.

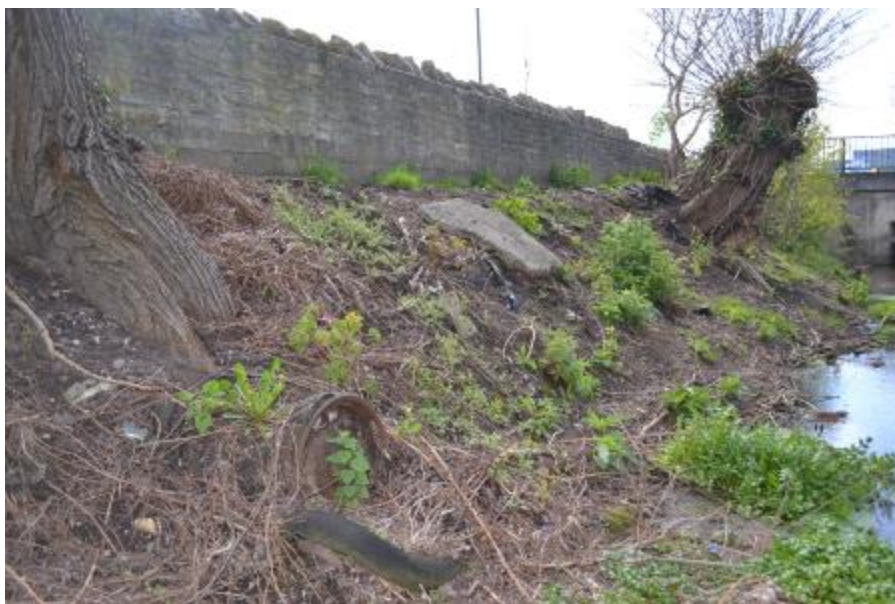
Figure 111: Exposed, littered and sparsely vegetated left bank of St. Andrew's Stream, located approximately 25m downstream of survey point SA5,

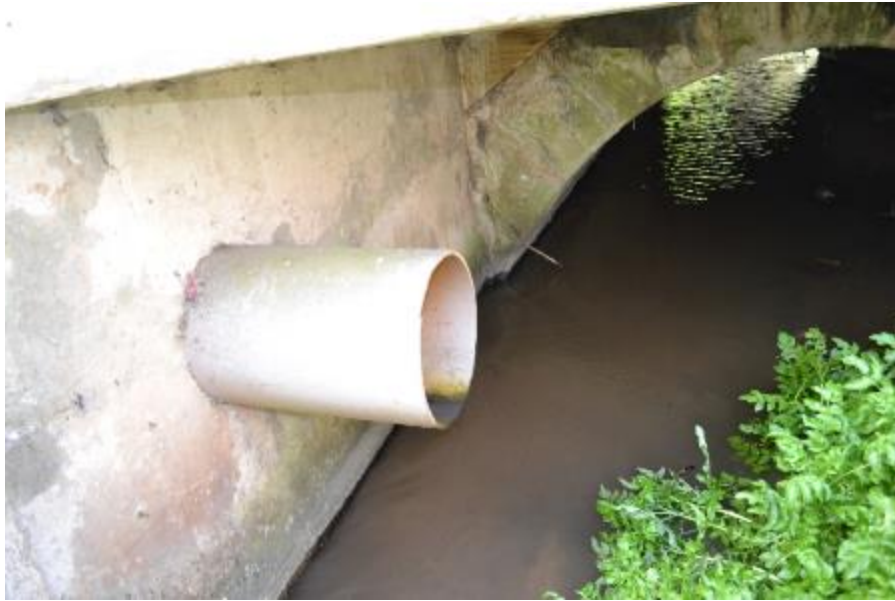
Figure 112: Discharge pipe located approximately 45m downstream of survey point SA5 on the left bank. The 30cm diameter pipe was odourless and was not discharging effluent.

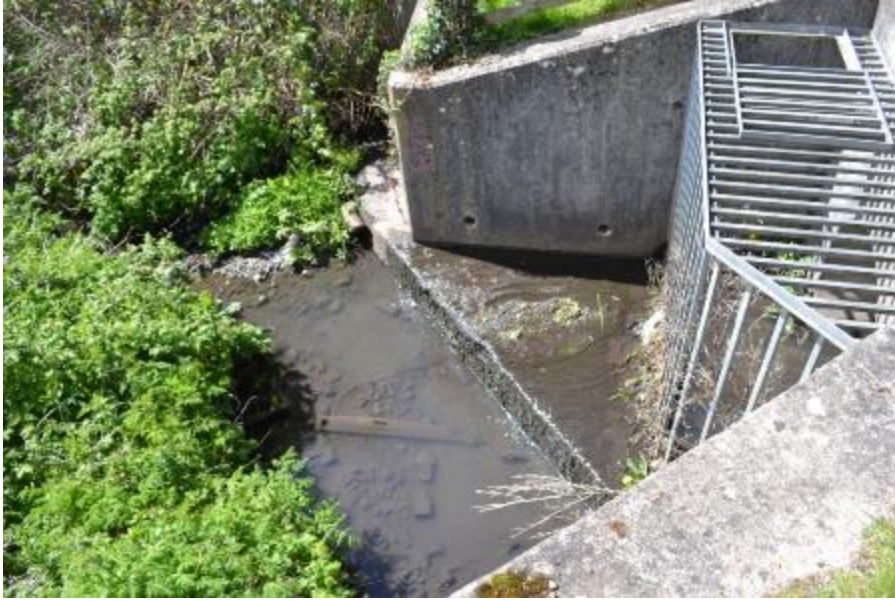
Figure 116: Culvert discharging water that passes through a screen filter at survey point SA6b. Litter is visible in the channel.

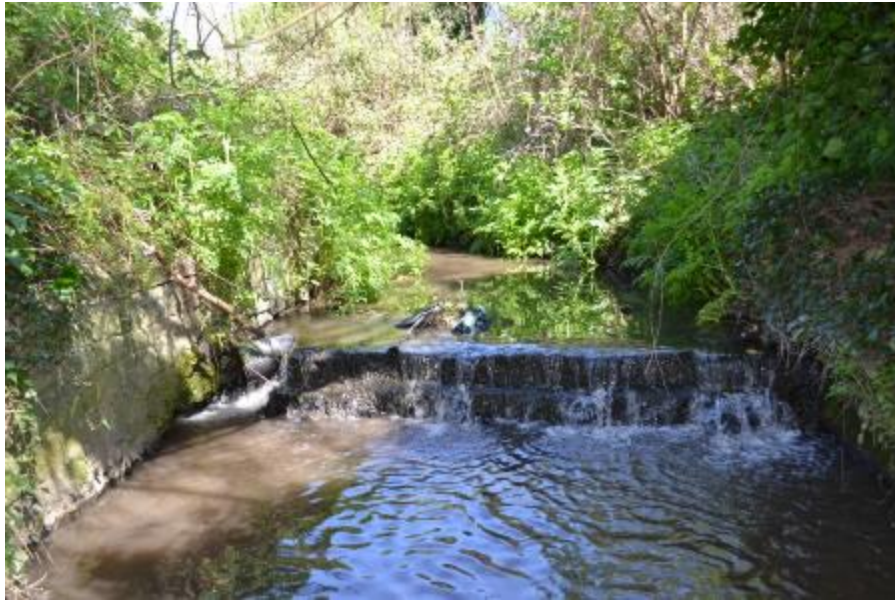
Figure 122: Upstream view of St. Andrew's Stream where it flows over a small weir, located approximately 25m downstream from survey point SA7a.

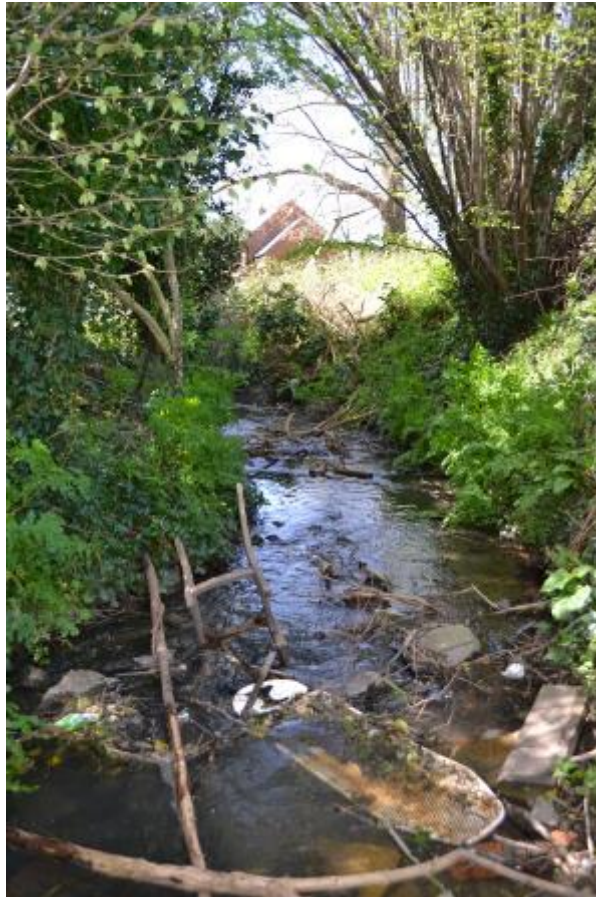
Figure 124: Figure 123: Litter visible in the channel of St. Andrew's Stream 65m downstream from survey point SA7a.

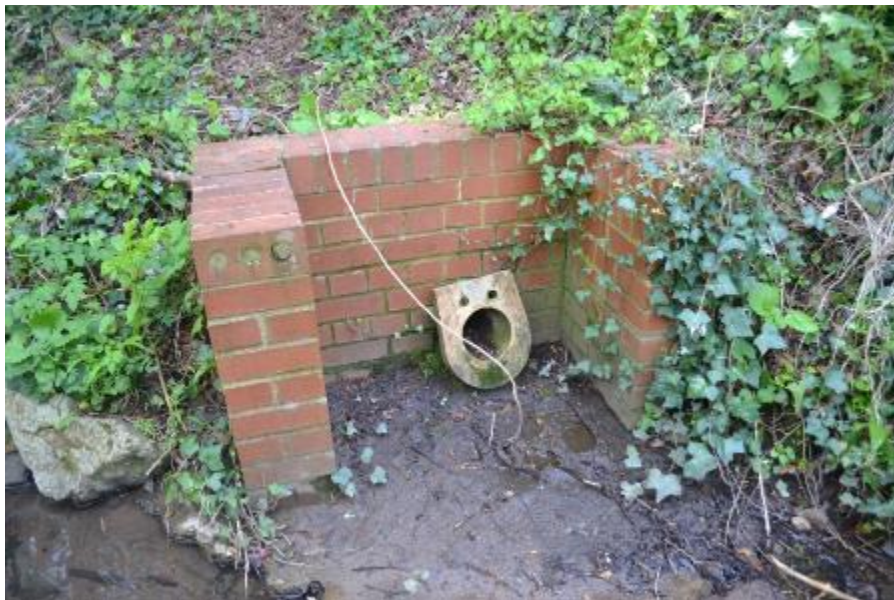
Figure 125: 10cm diameter discharge pipe located on the left bank of St. Andrew's Stream approximately 80m downstream from survey point SA7a. No effluent was flowing from the pipe and no odour was present.

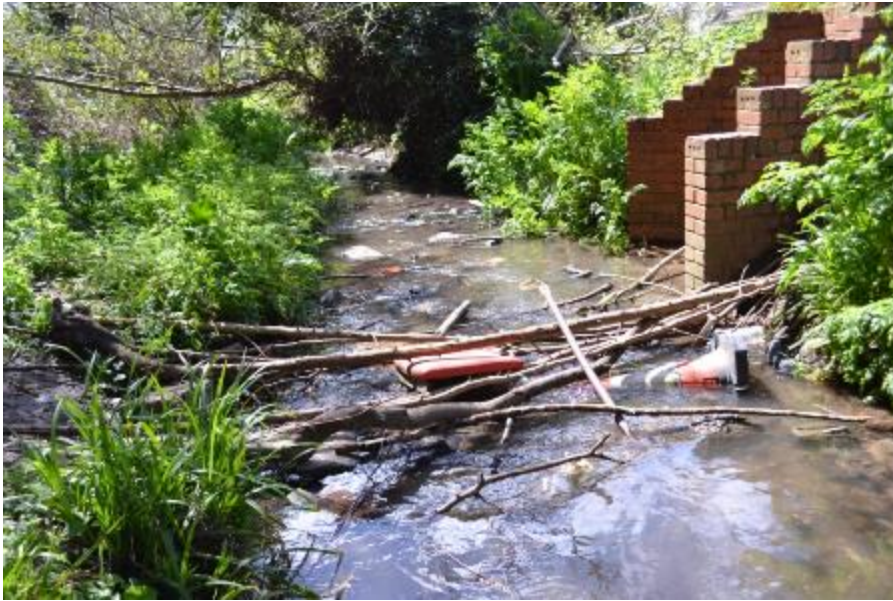
Figure 133: Litter visible in the channel of St. Andrew's Stream 15m downstream from survey point SA8.

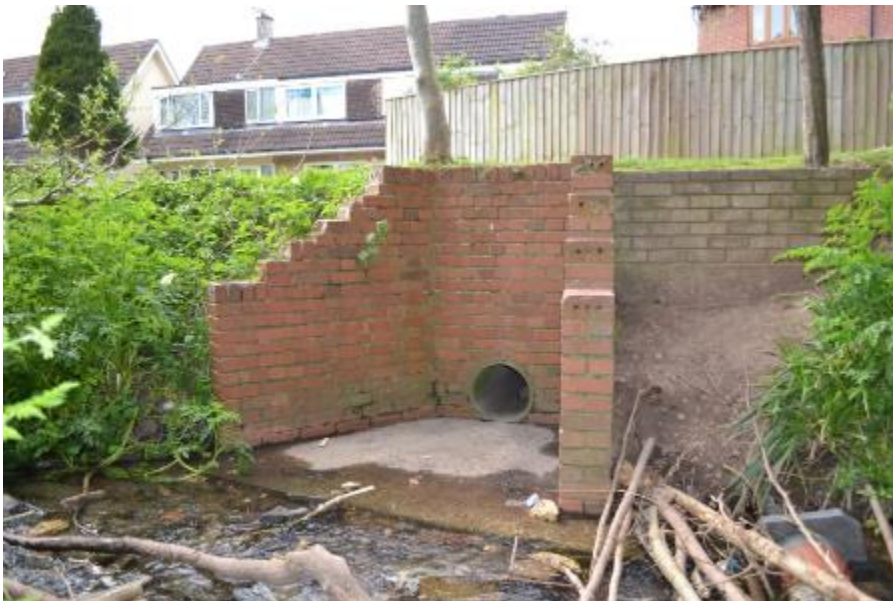
Figure 134: 30cm discharge pipe located on the right bank of St. Andrew's Stream 15m downstream from survey point SA8. No effluent was flowing from the pipe and no odour was present.

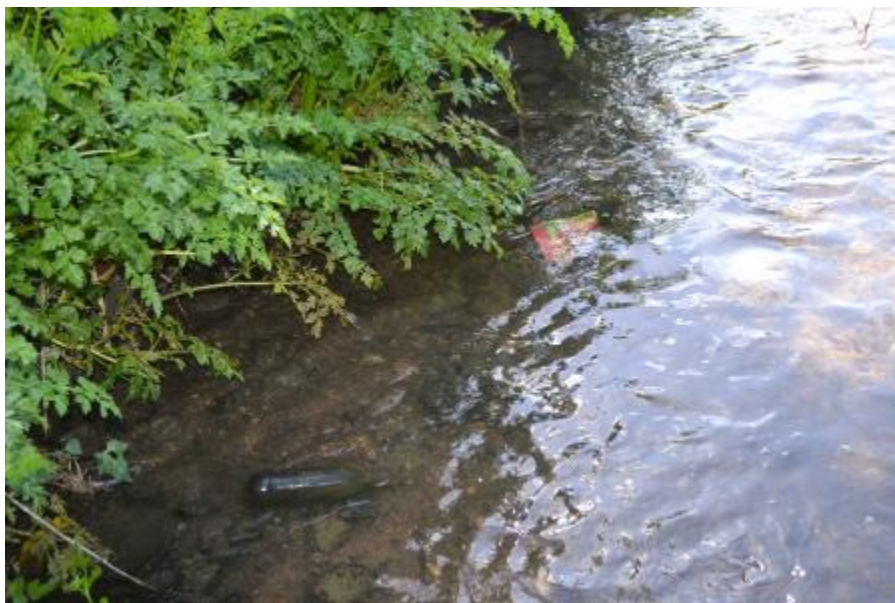
Figure 137: St. Andrew's Stream streambed substrate and litter at survey point SA9.

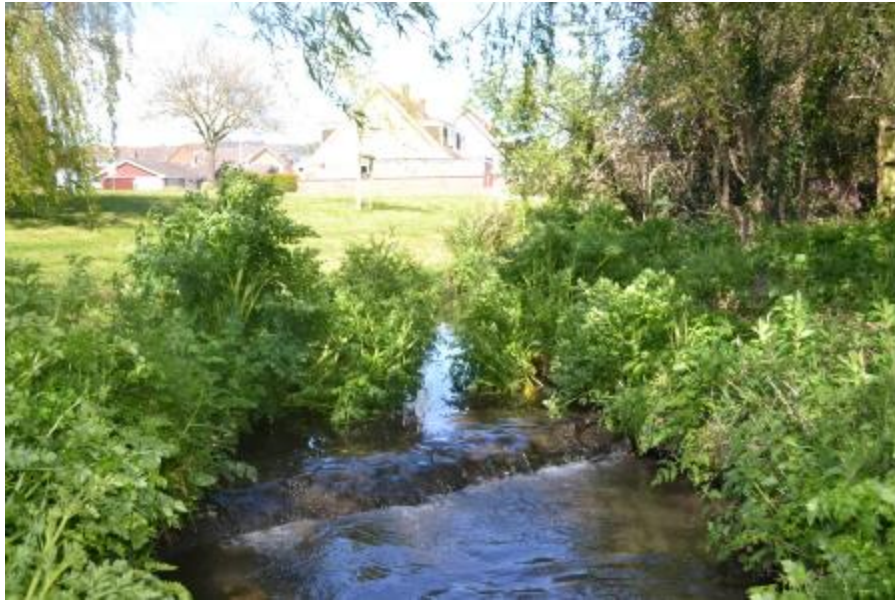
Figure 140: Upstream view of St. Andrew's Stream and a small weir located approximately 40m downstream from survey point SA910.

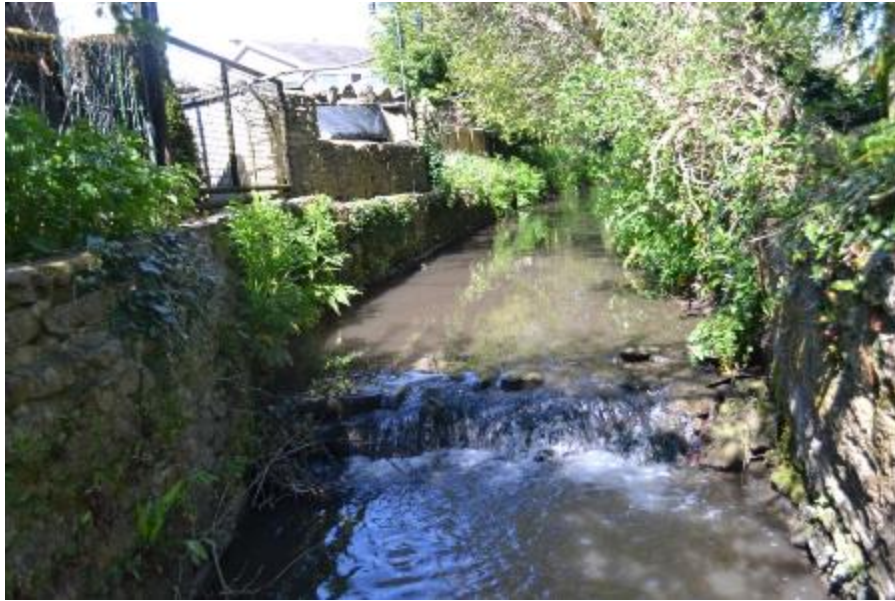
Figure 148: Upstream view of St Andrew's Stream and a small weir approximately 20m downstream from survey point SA912.

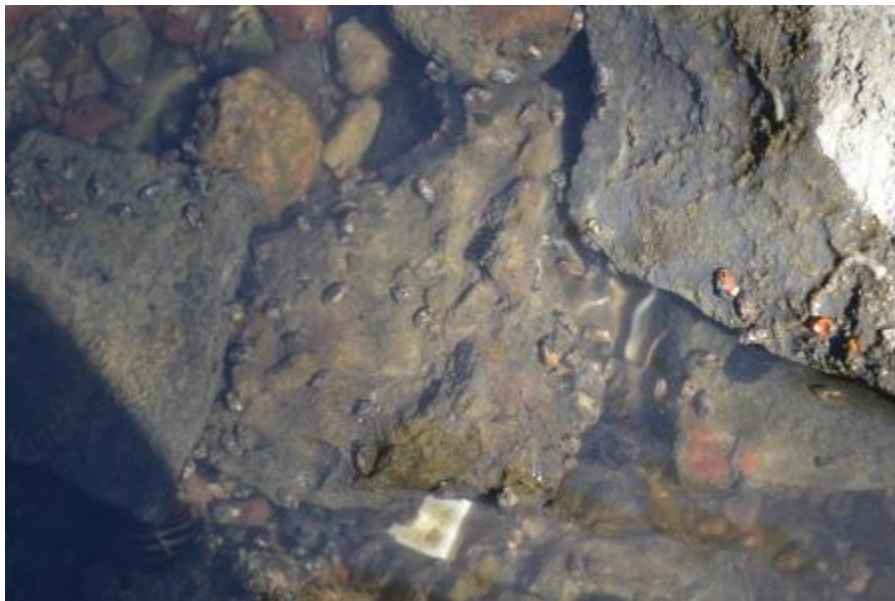
Figure 149: St. Andrew's Stream substrate covered in caddis fly larvae approximately 25m downstream from survey point SA12.

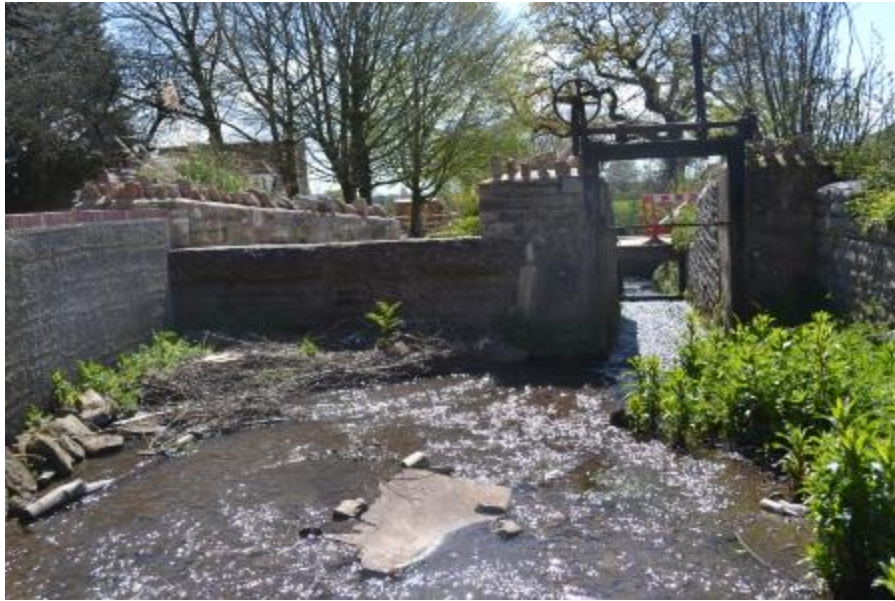
Figure 150: Downstream view of St. Andrew's Stream and disused sluice system approximately 75m downstream from survey point SA12.

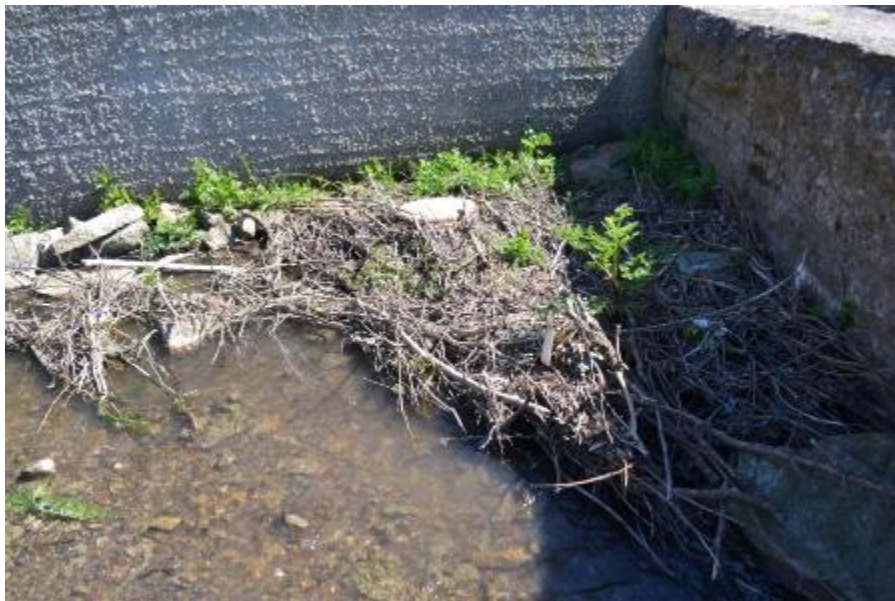
Figure 151: View of debris and litter accumulation on the left bank of St. Andrew's Stream just before a disused sluice system located approximately 75m downstream from survey point SA12.

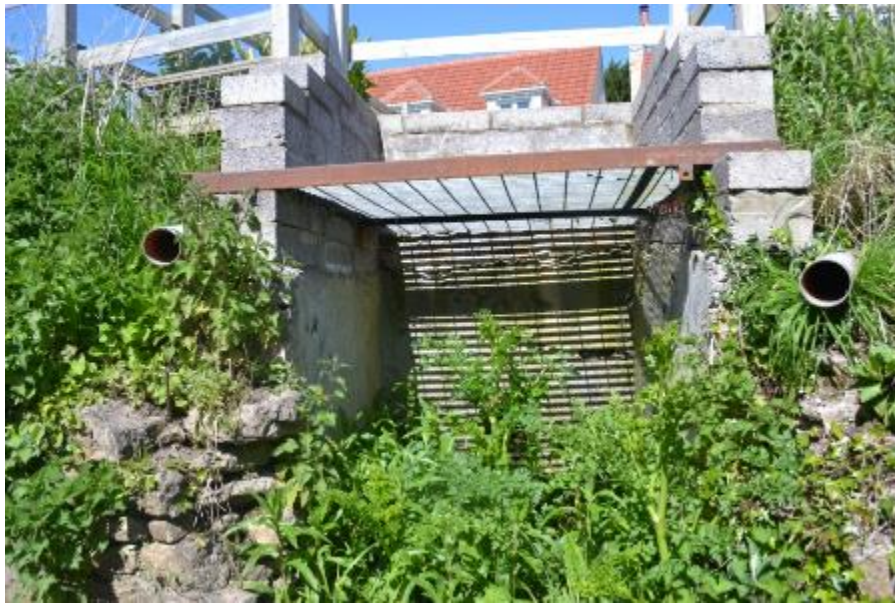
Figure 155: Two 10cm diameter discharge pipes and a single 20cm pipe (behind vegetation) on the left bank of St. Andrew's Stream approximately 65m downstream from survey point SA13. The purpose of the 10cm pipes in not known although a mild foul smelling dour was present.

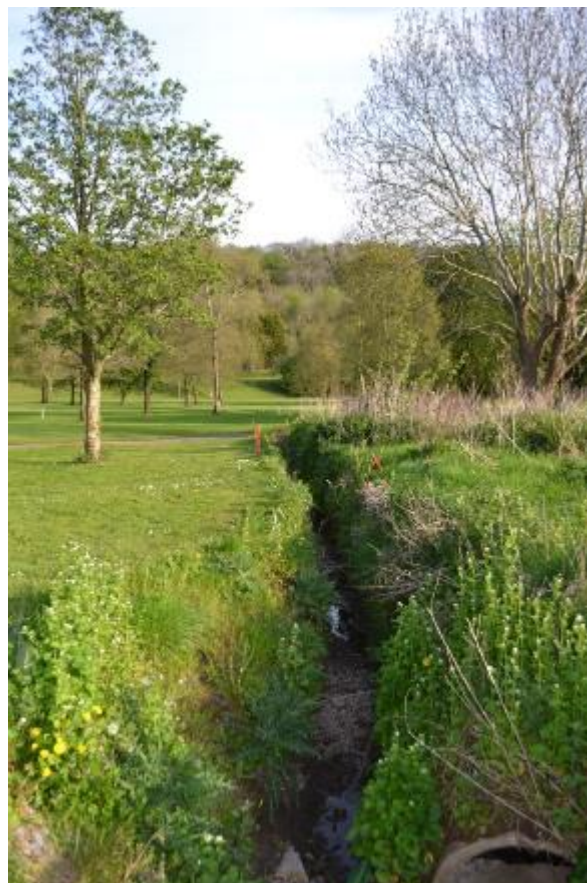
Figure 166: Downstream view of St. Thomas's Stream approximately 45m downstream from survey point ST2. The stream cuts through the grounds of Wells Golf Club from this location.

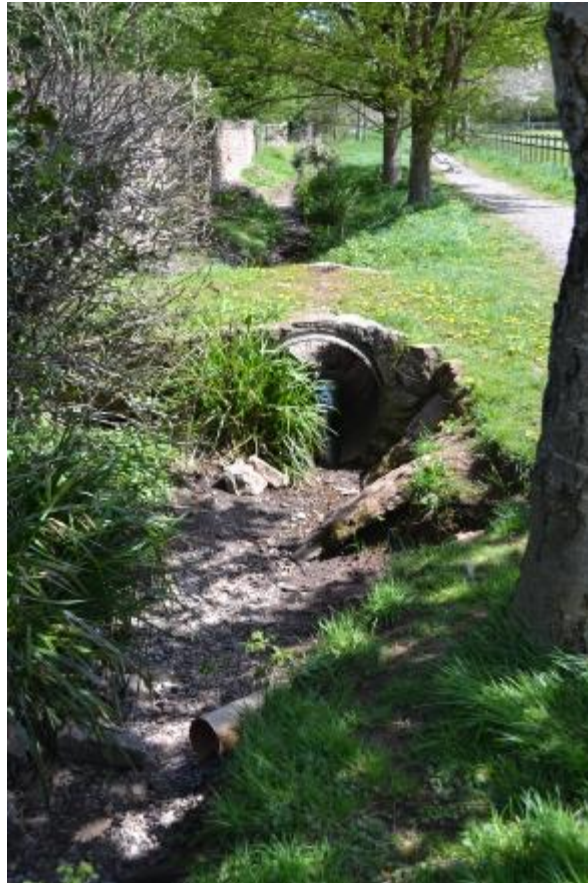
Figure 178: Upstream view of St. Thomas's Stream approximately 70m downstream of survey point ST8. A culvert and a 16cm diameter pipe (on the left bank) are visible.

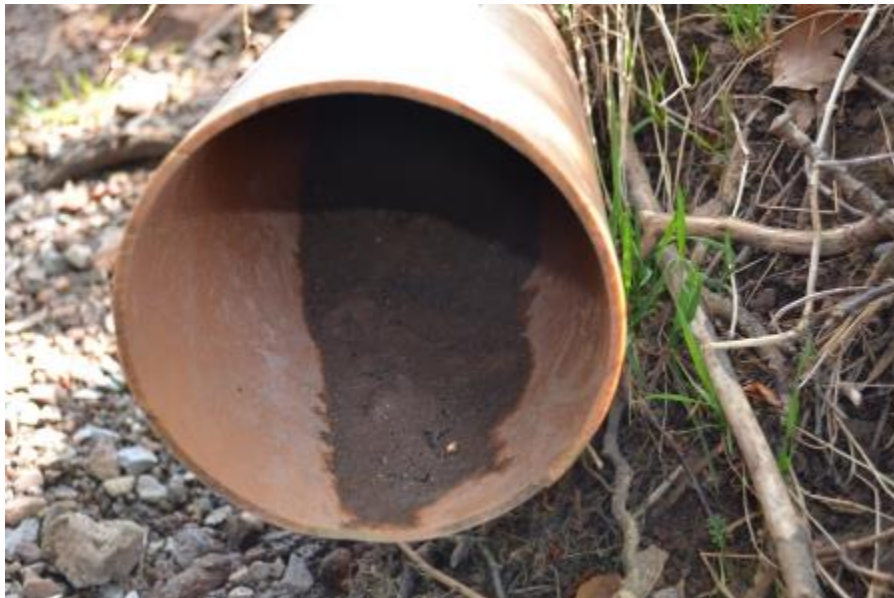
Figure 179: Close up image of sediment in a 16cm diameter pipe located approximately 70m downstream of survey point ST8. No effluent was being discharged and no odour was present

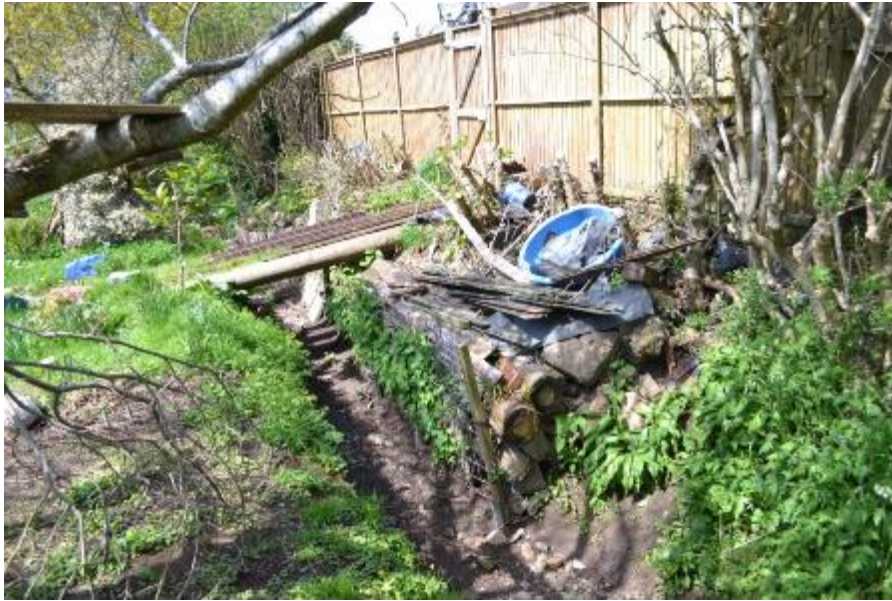
Figure 186: Downstream view of St. Thomas's Stream and bank modifications approximately 50m downstream of survey point ST11.

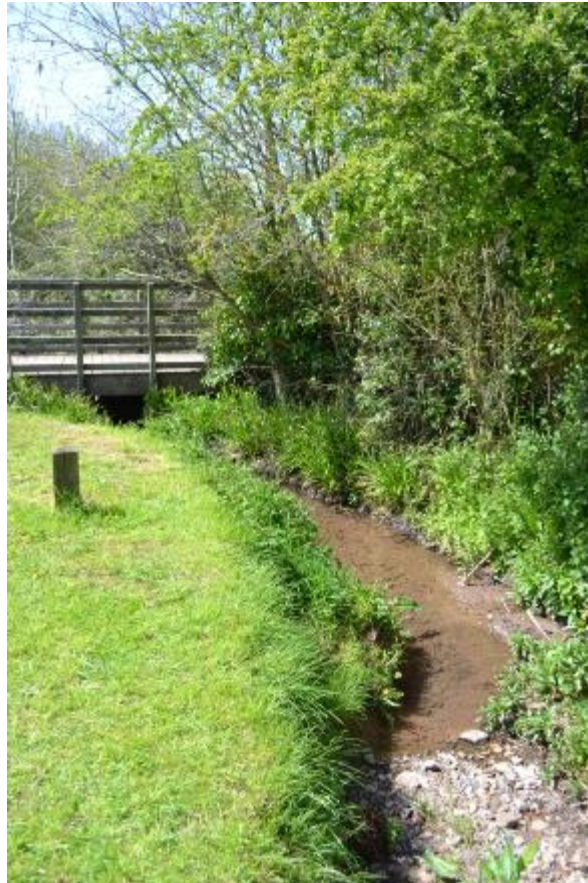
Figure 190: Downstream view of St. Thomas's Stream approximately 50m downstream of survey point ST12. Note the presence of water that enters the stream from the right bank (not visible).

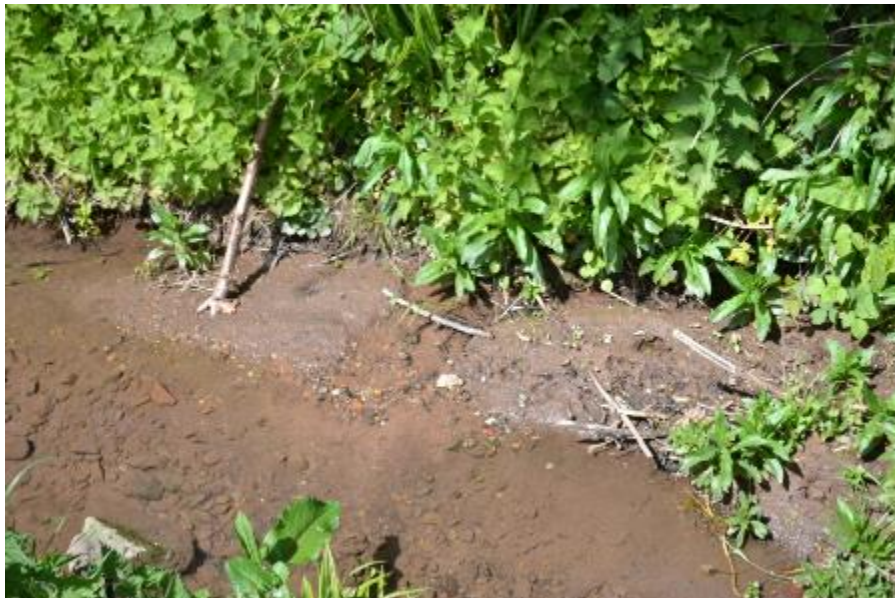
Figure 191: View towards the right bank of St. Thomas's Stream approximately 50m downstream of survey point ST12. Water is entering the stream from a spring that emerges from the right bank.
